Relationship Between Longitudinal and Temporal Streamwater Chemistry Across Streams

Joseph T. Malin

GEOL 394

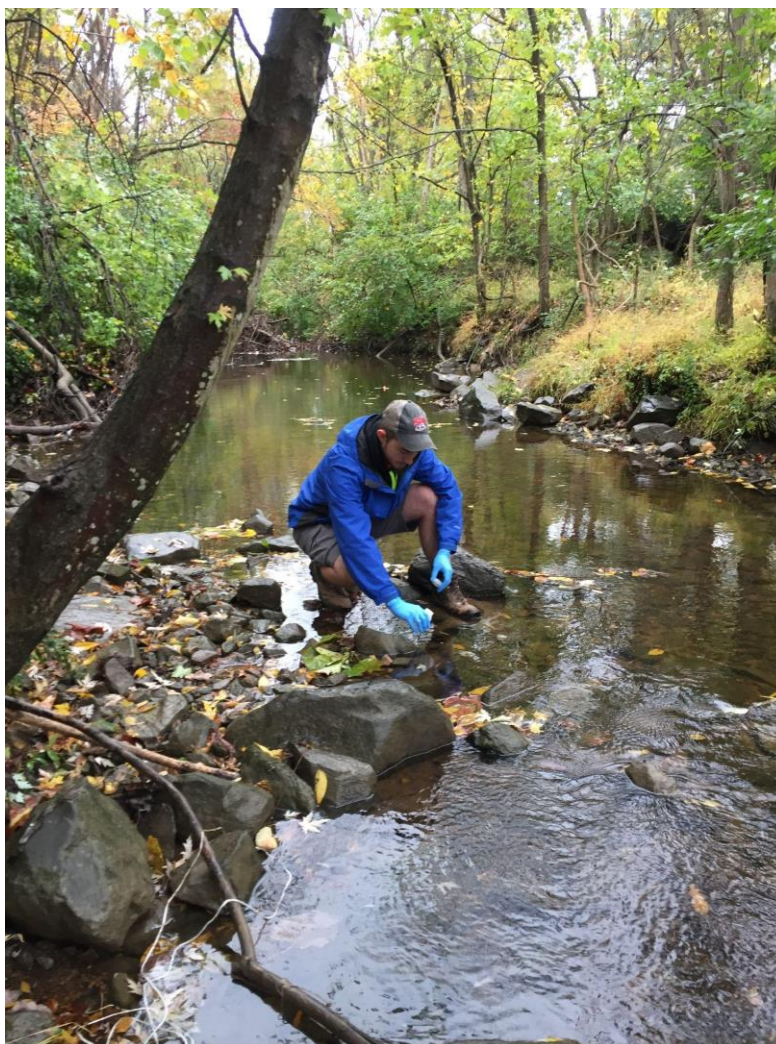
Photograph 1. Stream sample collection at Site SLB10. Photograph provided by Carly Maas. Additional stream sampling photographs available for reference in Appendix B.

On a field data collection day, a 150 mL sample bottle for every site, along with a water chemistry probe and a pair of latex gloves were transported to the field site. At each site and while wearing gloves, the sample bottle was opened, rinsed out three times in the stream, and filled with water from the channel on the fourth submersion. The bottle was then tightly closed and labelled for future identification from other samples. The probe was then submerged in the streamwater to its required depth and held still until its readings were steady. Probe measurements were recorded in a water-resistant field notebook along with the time of the data collection and any important notes to remember about the site. A table of water chemistry data from the March collection at Scotts Level Branch is available as reference in Appendix C. Once all stream sites were sampled, all the samples were brought back to the laboratory where they were filtered, acidified, and processed.

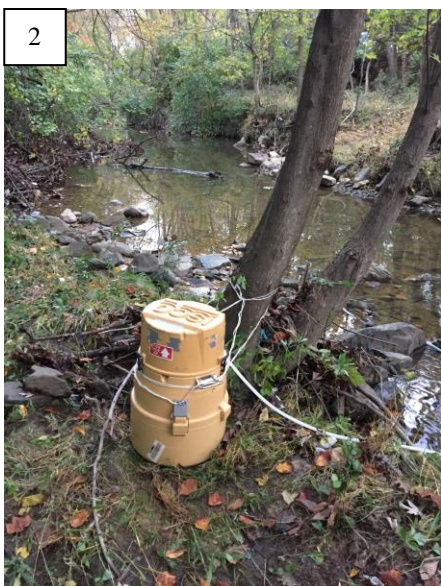
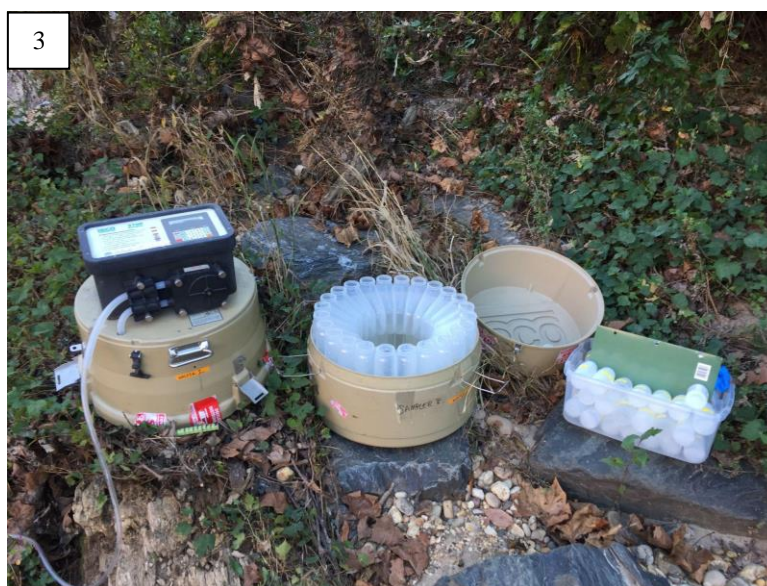
Photographs 2 and 3. Photographs of automated samplers in the field at Sites SLB10 (Left) and PB8 (Right).

Automated water samplers were occasionally operated in conjunction with field data collection days. The auto-sampler would be transported to its location on the stream either the day before a field collection day, or right before starting downstream sampling. The choice between the two options had little reasoning other than when time was available to make the trip. The sampler was placed on level ground somewhere near the edge of the channel, in some cases tied down to prevent movement from rising water levels during storms (Photograph 2). A ten-foot-long segment of quarter-inch clear tubing was connected on one end to the sampler pump, and the other end was placed in the stream and weighed down with stones. The auto-sampler was then programmed to collect 250 mL of streamwater every sixty minutes for the next twenty-four hours starting immediately. When the program started and the first sample was collected, the first interior sample bottle was checked for the correct amount of water, and the time was recorded for future analysis.

When returning to the automated sampler the following day, twenty-four 150 mL sample bottles were labelled and brought to the auto-sampler location. Every bottle in the sampler was paired with a 150 mL sample bottle, and the hourly stream samples were moved into the smaller bottles for easier transport of the auto-sampler out of the field (Photograph 3). Sample bottles were then brought back to the laboratory to be processed. The automated sampler was also brought back to the laboratory for cleaning.

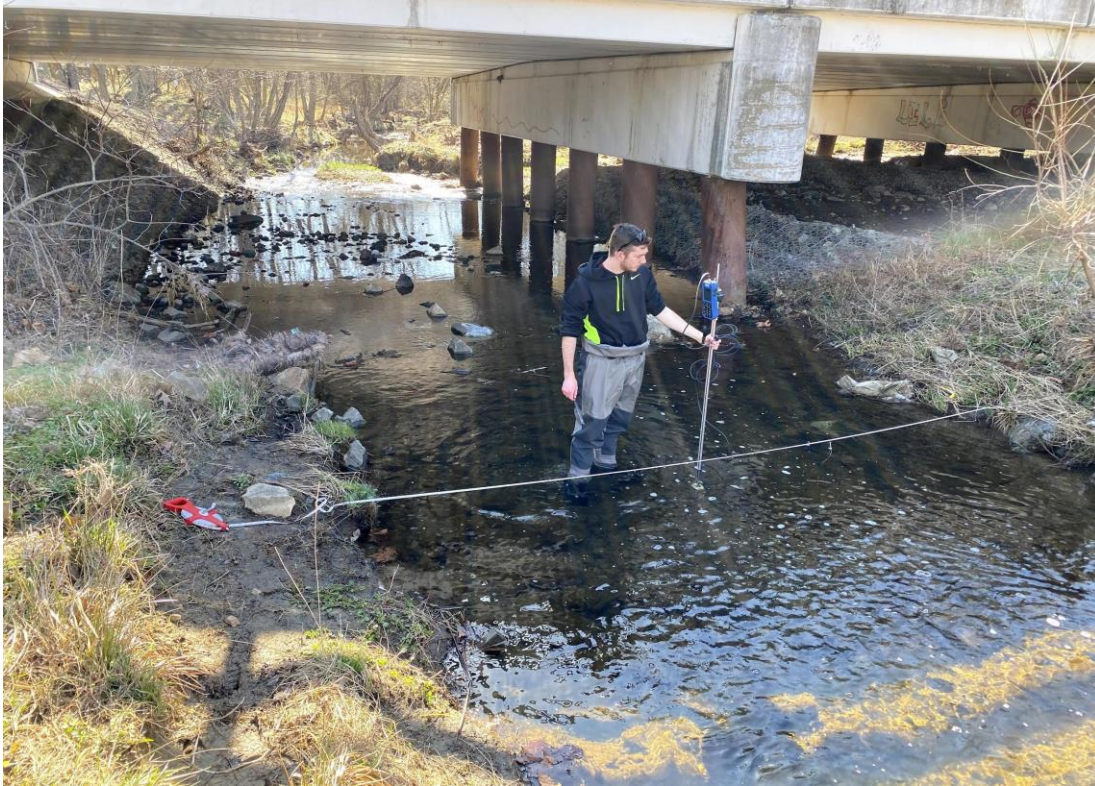
Photograph 5. Stream velocity measurements taken with an acoustic velocity flow meter at Site SLB5. Photograph provided by Christiana Hoff. Additional photographs of measuring stream velocity available for reference in Appendix B.

A Hach Flomate velocity flow meter was then placed at each predetermined increment to record local stream velocities. To save time in the field, the velocity meter was connected to its sensor and attached to the telescoping stand at the initial data collection site, then safely transported as one piece to each following site, and then disassembled at the end of the collection day. While taking the velocity measurements, the velocity meter and its sensor were always upstream of the operator so that the operator did not interfere with the flow of the water or the velocity meter's readings. At each increment, obstacles in the way of the velocity meter stand base were temporarily moved to provide it with a stable position. The sensor was then elevated to two thirds of the water's depth, or one third off the stream bed. This value was found through simple calculations and measured with the ruler or yardstick.

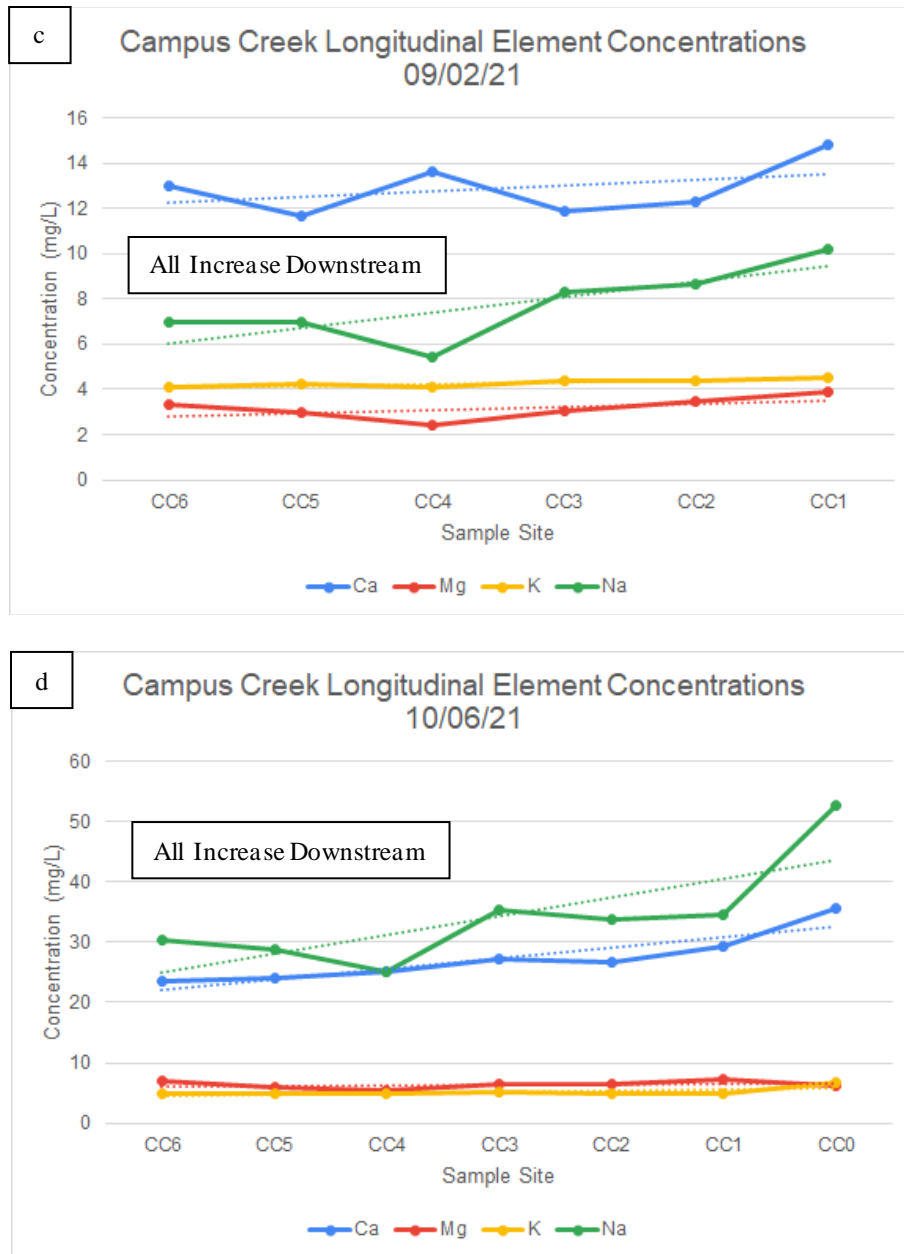
Figure 3. Base cation concentrations of downstream samples from Scotts Level Branch (a), Paint Branch (b), and Campus Creek (c,d).

Figure 3 shows the concentration of base cations at all three monitored streams. In Figure 3, there were all positive trends across two collection days at Campus Creek for samples taken about a month apart (3c,d). Base cation concentrations measured at Campus Creek during this monitoring experiment are comparable to two previous studies from Yaculak et al. 2021 and Silberstein et al., 2019. Similar positive trends were measured at Paint Branch for Ca, Mg, and K, but there was a contrasting negative trend for Na (3b). Paint Branch spikes in most measured base cation concentrations at Site PB8, which is just downstream of the Campus Creek input and a local construction site near the stream. Measurements at Scotts Level Branch, however, show

all negative trends (a). This means that the stream is either diluting or retaining these base cations as water moves longitudinally through the channel.

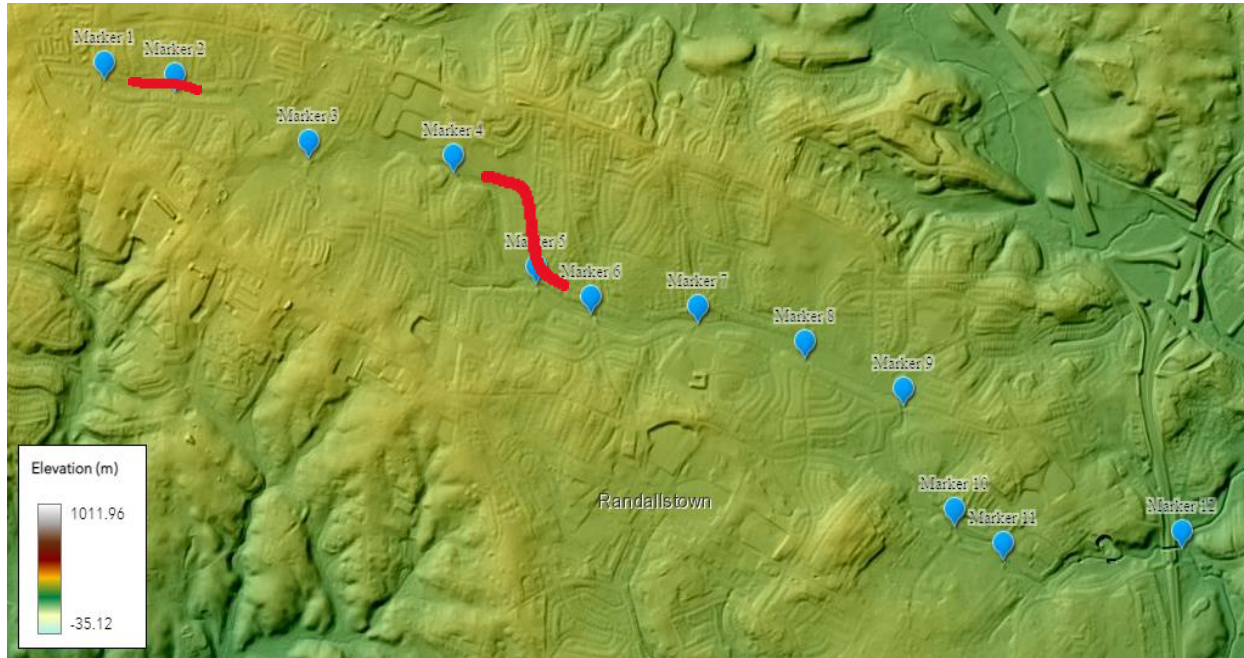
Figure 10. LiDAR imagery map of Scotts Level Branch with data collection site markers. Restored areas of the stream are marked in red. The first segment of the project was constructed between Site SLB4 and Site SLB5. The second segment was constructed between Site SLB1 and Site SLB2.

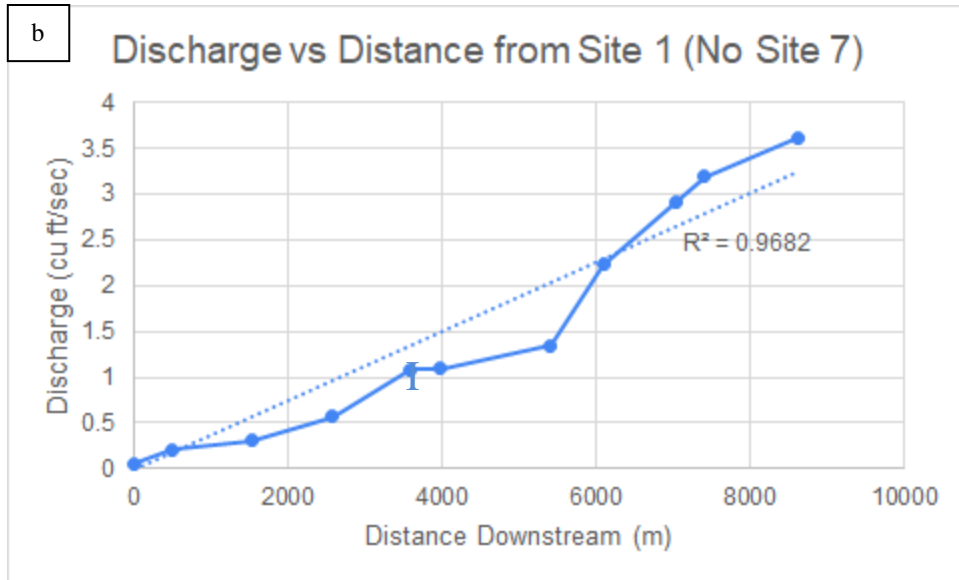
Figure 11. Plots of calculated discharge at each site represented by their distance from Site SLB1. The negative discharge measurement at Site SLB7 is included in the top plot (a) to show all calculated data, and not included in the bottom plot (b) to provide a more accurate representation of the overall stream discharge trend. An error bar is used for the Site SLB5 measurement to account for the ~10% error between the two recorded data sets. Additional downstream data at Scotts Level Branch is available for reference in Appendix H.

From headwaters to downstream, the discharge and average stream velocity show increasing trends in the data analysis at Scotts Level Branch. The site with the highest average velocity is Site SLB10 at 0.32 feet per second, and the site with the slowest average velocity is Site SLB1 at 0.01 feet per second. The calculated field discharge measurements increased at a steady rate downstream, with the exception of Site SLB7, where the discharge calculation came out to be -1.498 cubic feet per second (Figure 11a). This site was located at the base of an urbanized section of stream that had a concrete channel, and the water was flowing into a large pool at the end of the channel. Within the large pool, it could be seen that the surface water was not only flowing downstream, but also circling back around the pool to the concrete section. These upstream currents could be eddies or hydraulic currents. The cross sectional and discharge measurements were taken where the upstream current was stronger than the downstream current, producing what looks like a negative discharge calculation at the data collection location. This negative value skews the data analysis tables involving discharge and can easily be spotted in the Discharge vs Distance from Site SLB1 graph shown below (Figure 11). Clearly, the average channel discharge at Site SLB7 was not accurate, in part due to the complex flow paths within that segment of the stream. According to the discharge measurement at the end of the stream, Scotts Level Branch was feeding over 1,600 gallons of water per minute into Gwynn's Falls at the time of data collection.

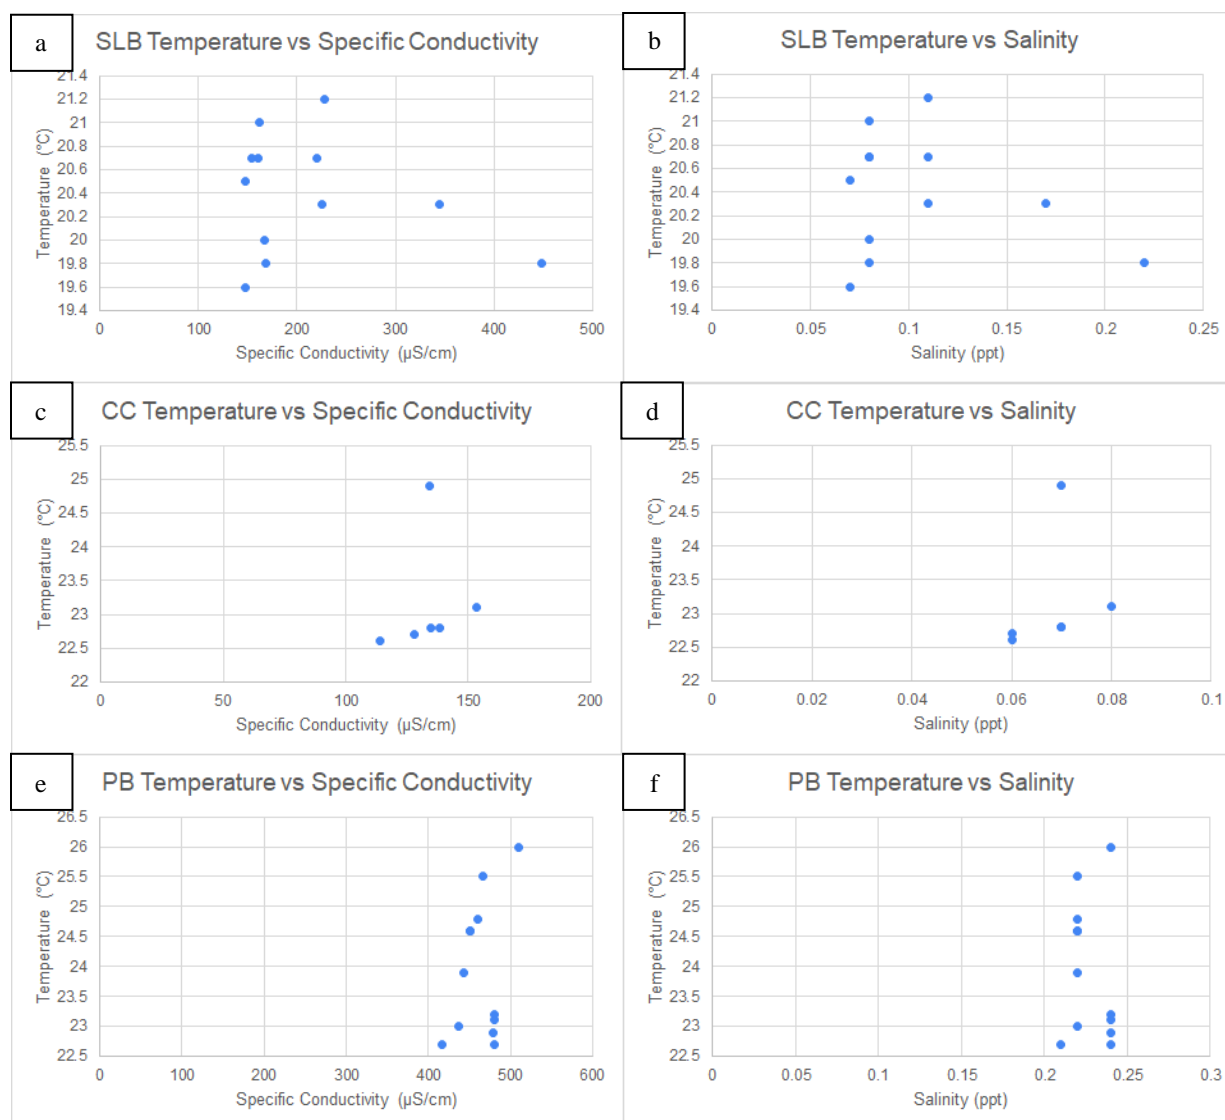
Figure 15. Plots showing specific conductivity and salinity relative to water temperature for each data collection site across all three streams. Similarities to review between plots are from left to right, not top to bottom (i.e., a to b, c to d, and e to f). Note that the plots from stream to stream do not share the same scale. Scotts Level Branch (a,b) and Campus Creek (c,d) data were collected on September 2, 2021. Paint Branch data (e,f) were collected on September 16, 2021. Similar data was also seen at Scotts Level Branch on March 27, 2021, which can be found in Appendix J.

Two aspects of the water chemistry explored were specific conductivity and salinity. Specific conductance is a measure of how efficiently a water sample can pass an electrical current. The standardized method of recording conductivity is to take the measurement when the water sample is at, or corrected to, 25 °C (U.S. Geological Survey, 2019). A standard temperature variable across all data allows for easier comparisons within the data as conductivity ratios change with temperature (Pawlowicz, 2008). The efficiency of a sample to pass an electrical current is directly associated with the concentration of ions in the water. These conductive ions can come from dissolved salts in the environment, as well as from chlorides, sulfides, and carbonate compounds (SWRCB, 2004). Salinity is the total concentration of all dissolved salts in a water sample and is directly correlated to specific conductance. As salts dissolve, electrolytes form ionic particles, with each one having a positive and a negative charge (Maheshwari & Agrawal, 2020). Because specific conductivity and salinity naturally go hand-in-hand with respect to temperature, a correlation between the two should be seen in the field data analysis. This is exactly what data analysis expressed. The Temperature vs Specific Conductivity and the Temperature vs Salinity data analysis graphs from all three streams follow similar patterns (Figure 15). Other than a few outliers, the specific conductance and salinity show similar patterns with respect to temperature.

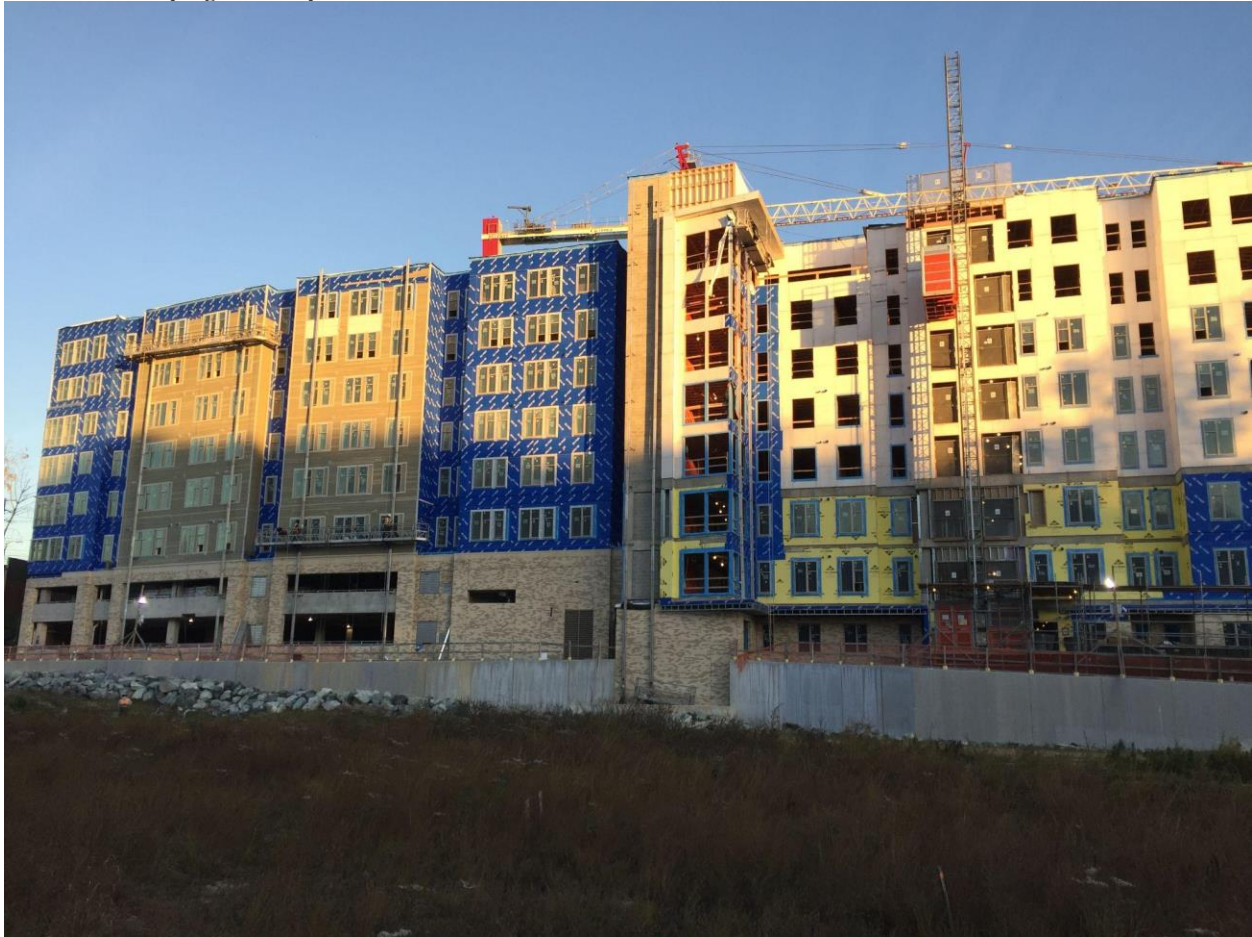
Photograph 6. Large building complex construction site along Paint Branch, upstream of Site PB7.

In the above photograph, taken from the Paint Branch floodplain, a large building is being constructed very close to the stream channel. This is one of many construction sites currently in the Paint Branch watershed at the time of the study. Construction near a stream can increase debris, TDS, and turbidity in the stream. Sudden spikes in longitudinal data may be caused by anthropogenic activity such as impervious sidewalks and parking lots, underground sewage pipes, or local rise in urbanization, like the one pictured above.

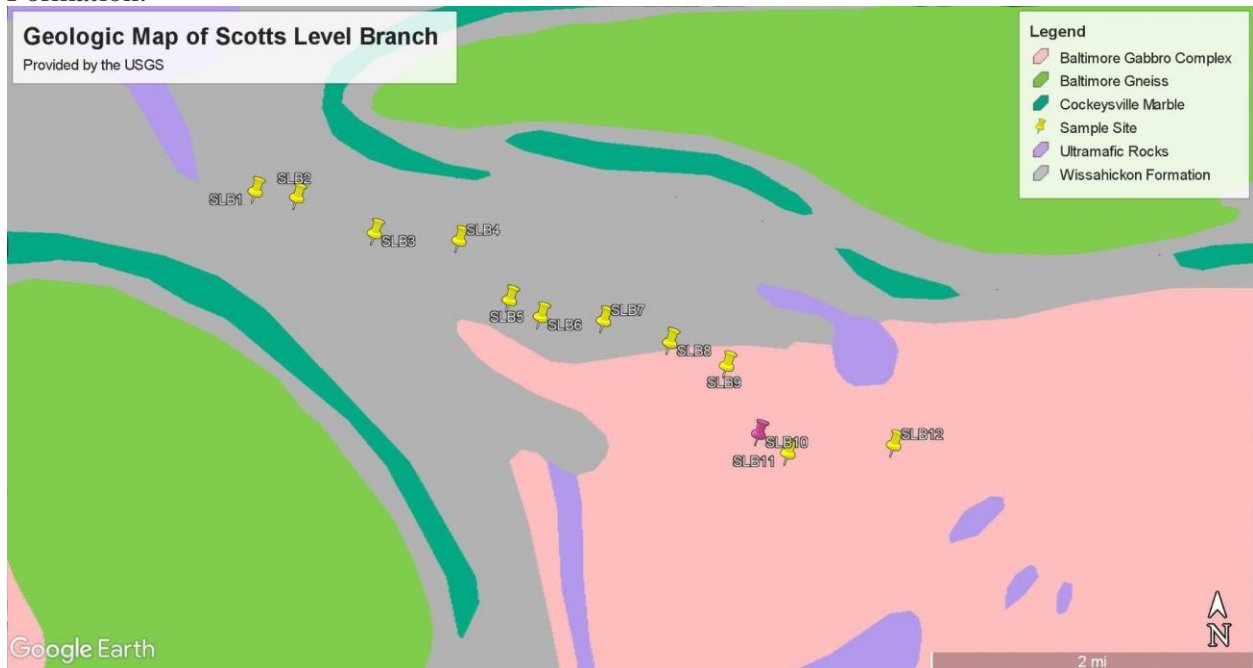
Figure M2. Geologic Map of Scotts Level Branch and Surrounding Area with Data Collection Site Markers. Base geology is from the USGS.

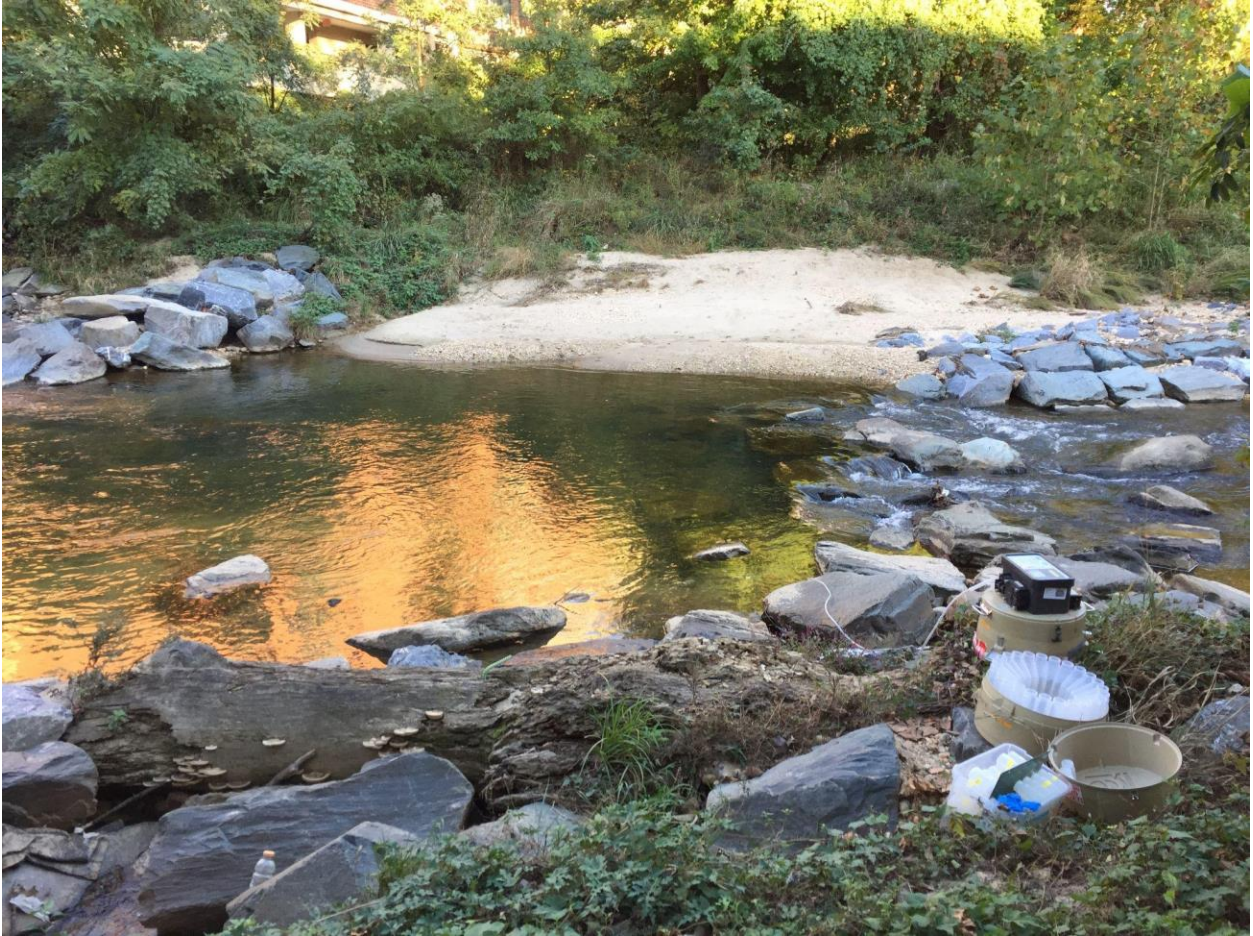
Photograph 16. Paint Branch automated sampler location at Site PB8.
