# EVALUATING HYDRAULIC AND VEGETATIVE EFFECTS ON RIVER BANK EROSION

GEOL 394

## **Abstract**

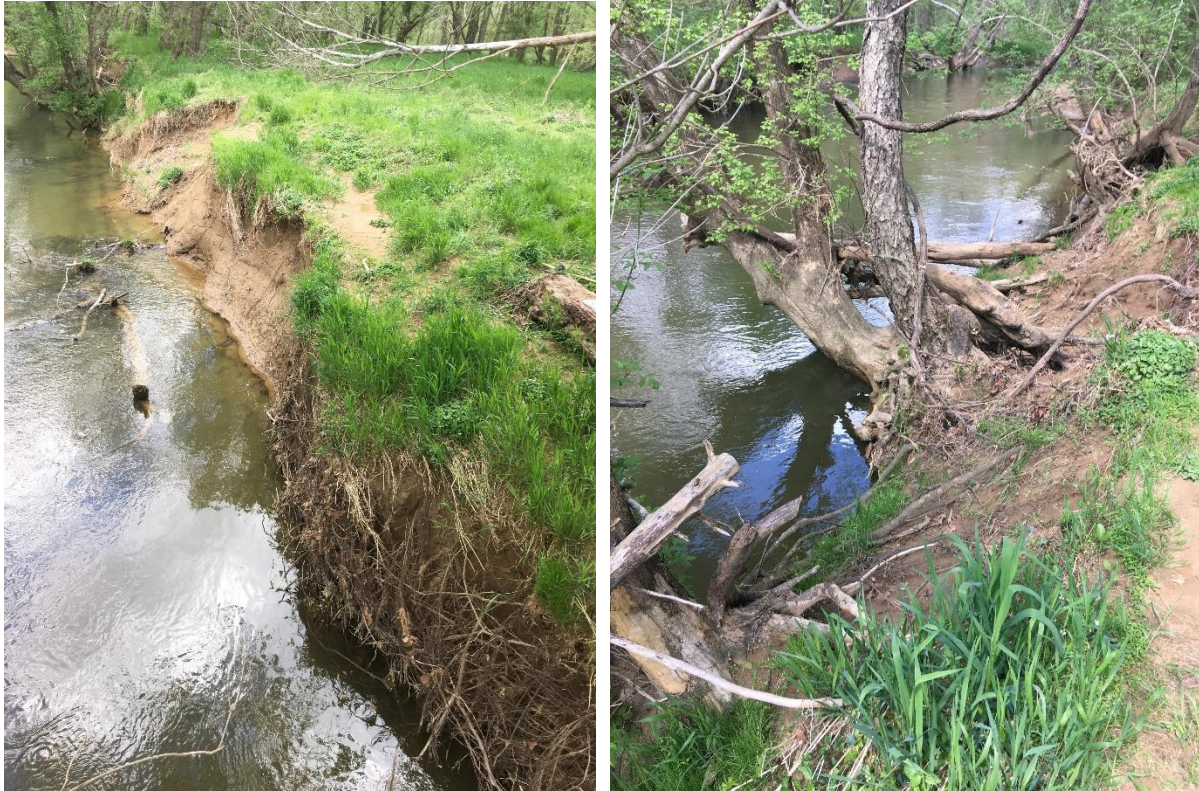
Figure 2. A photo showing exposed roots along a section of the bank of Seneca Creek

In addition to measurements of erosion rates, measurements of bank characteristics that might affect erosion rates can also be conducted. The root depth whether exposed or buried (due to bank erosion or overbank sedimentation respectively) plays an important role in determining the bank erosion in a specific area, the roots size and quantity within a bank work to prevent bank erosion by strengthening the structure of the bank and holding it in place (Pizzuto and Mecklenburg 2009, Malik 2006.).

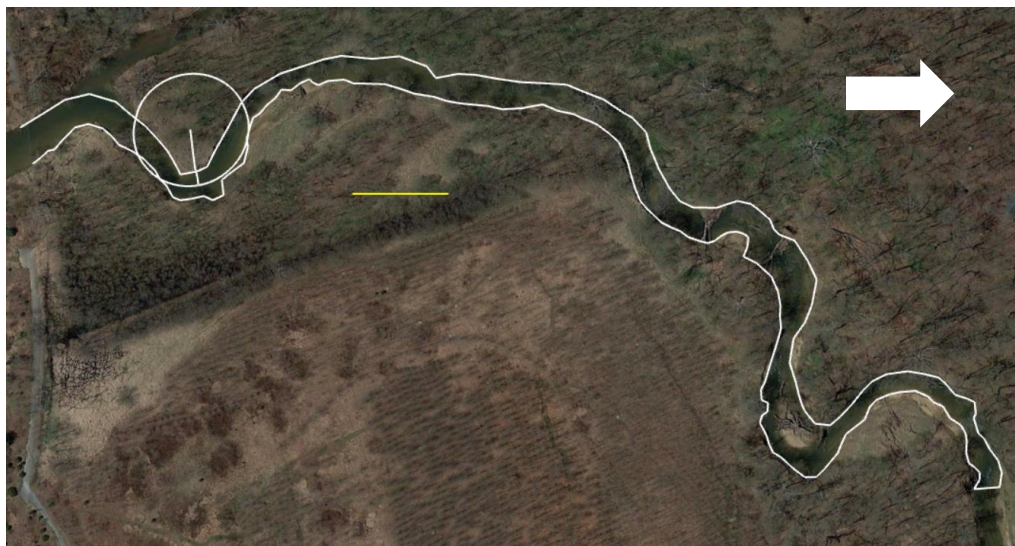
Figure 3. An air-photo of the study area along Seneca Creek. The superimposed yellow bar represents 100 meters length, the superimposed white arrow represents north direction. The superimposed circle shows the radius of curvature for one of the meander bends.

The study site is a section of Seneca Creek near Dawsonville, Maryland (fig. 3). The site is located upstream of a USGS gauging station. The Seneca Creek watershed contains rapidly suburbanizing areas in Rockville and Gaithersburg, Maryland. As a result, peak discharges in the watershed have been increasing over the past few decades (fig. 4). Examination of the field site indicates high rates of bank erosion (exposed roots, fallen trees, etc.) as well as overbank deposition of coarse sand. During the observation period, I monitored bank erosion that undermined the root structure of a tree (fig 9), which suggests that bank erosion is an active process as whole in this river and specifically in the chosen study area.

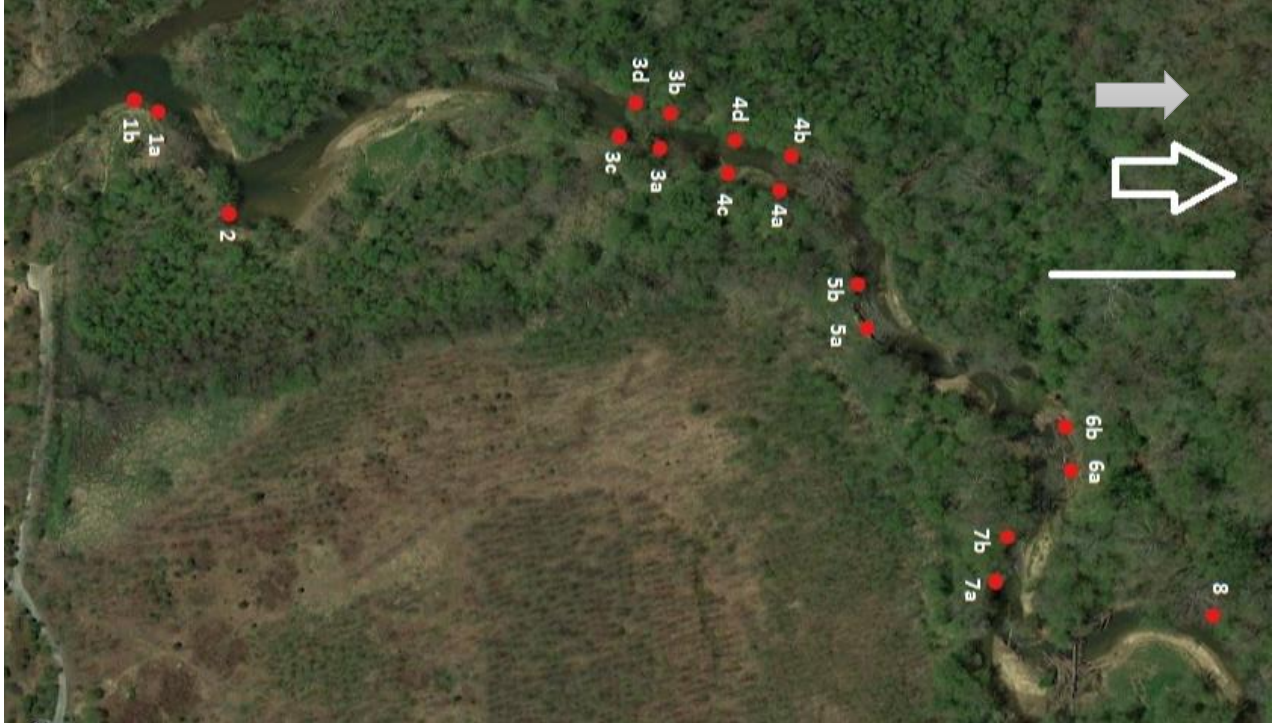
Figure 6. Air photo of the study area displaying where specific sites for measurements are located. The superimposed white bar represents 100 meters on the ground and the white arrow is north direction.

The first part of my study used USGS gauging station data. These data extend over a significant period of time, but only provide information about one cross section of the river. In this part of my study, I examined spatial differences in bank erosion rates, and associated variations in channel morphology and bank characteristics. For this part of my study, I have selected 8 areas along of a reach of Seneca Creek (fig. 6).

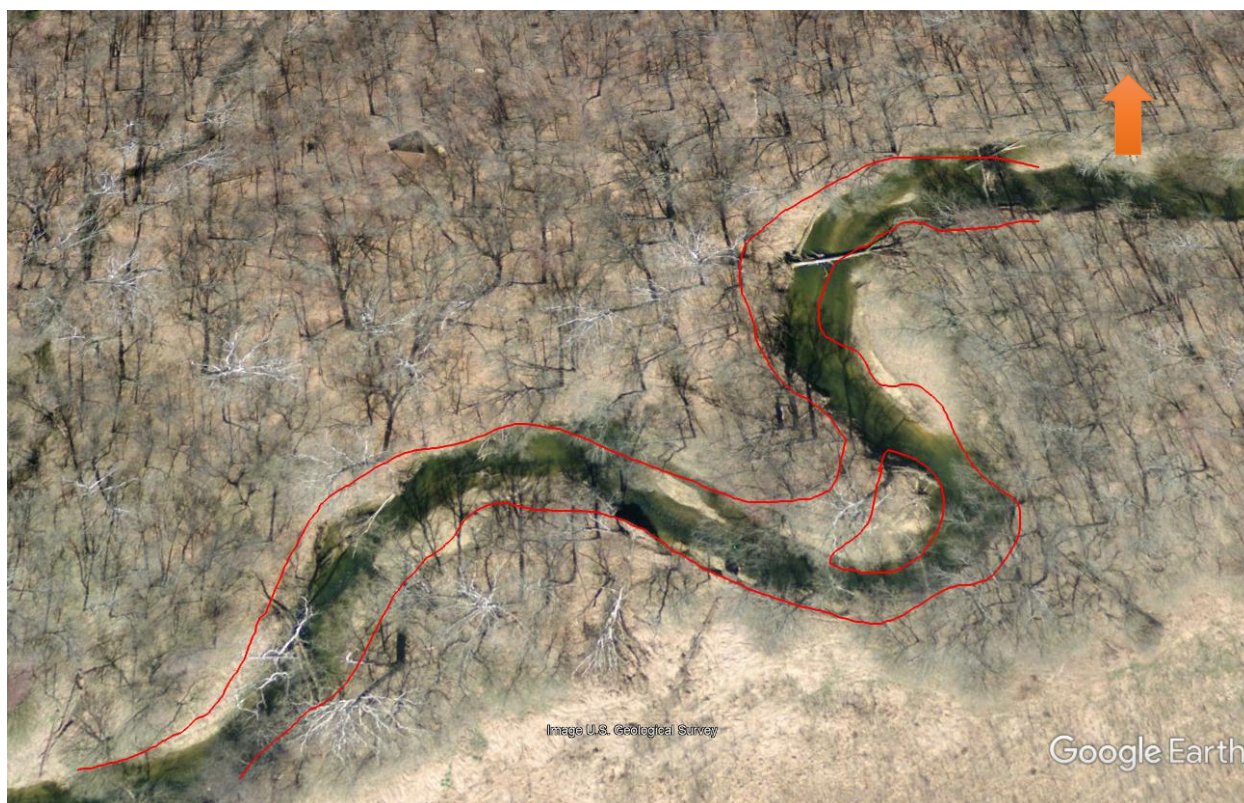
Fig. 7: Channel Boundaries from the 4/2008 channel shown on the 4/2018 image (drawn in Google Earth, the image is from the USGS for both years, the orange arrow is north direction). Note the cut-off chute that was formed and subsequently reconnected in the middle of the bank.

These reaches of river were selected to provide a range of planform morphology ranging from tight meander bends ( $R_c$  of 20.12 m) to open meander bends ( $R_c$  of 29.67 m) to straight reaches (table 2). For these selected reaches, migration rate was estimated by measuring the changes in channel area for each segment divided by the segment length for the 4/2008 and 4/2018 air photos (which were the best resolution and taken during dormant periods for vegetation). These migration amounts were divided by the time interval (10 years) to obtain migration rate. Examples of channel changes between the 2008 and 2018 channels on the air photos are shown in fig. 7.

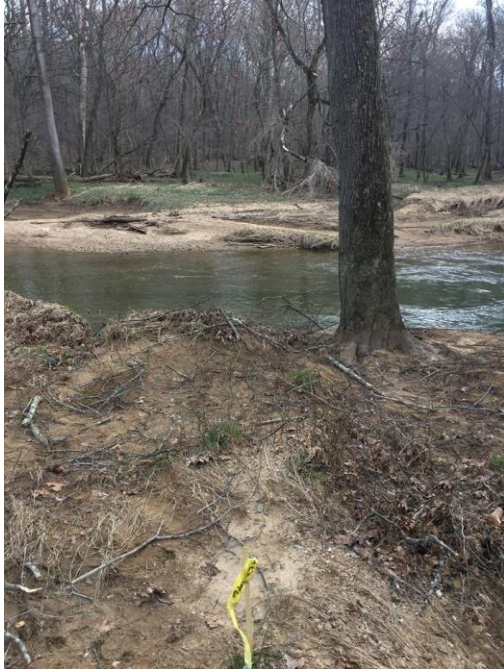
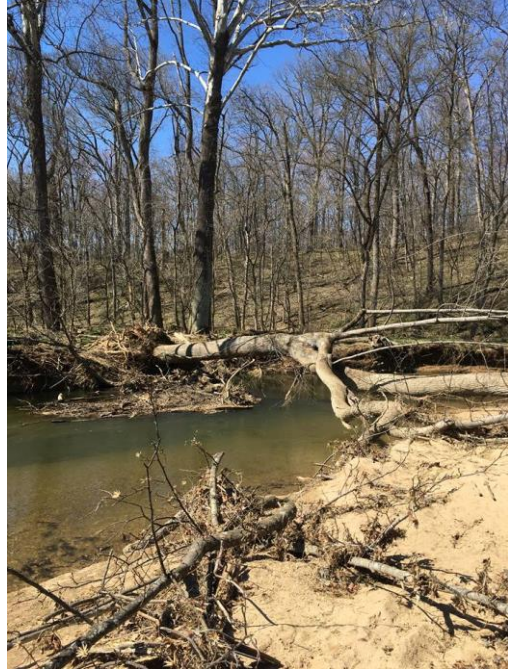
Figure 9. A set of photos showing a tree that had fallen within at least a week of observation.

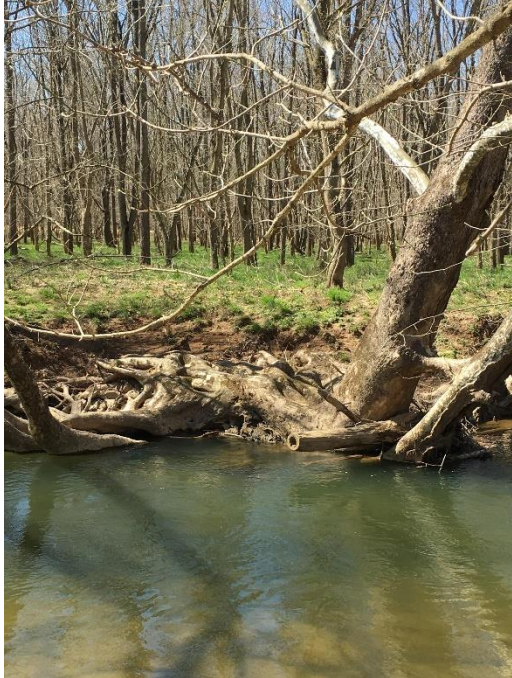
Figure 10. A photo showing the exposed root systems of a tree that had been growing on a bank that has since eroded inland.

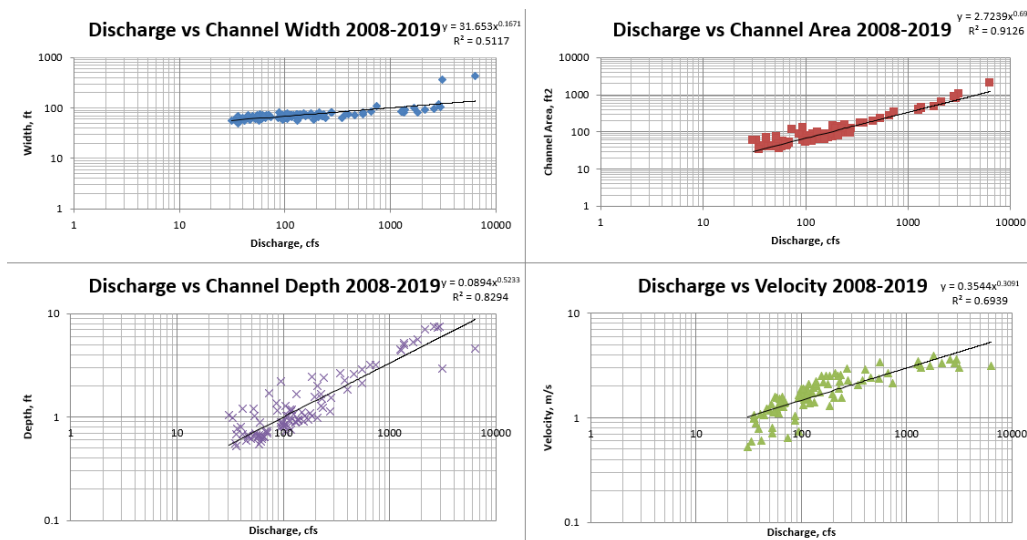
Figure 11. These graphs are an example of the hydraulic geometry relationships taken from USGS gauge data for the years 2008 to 2019. Bankfull discharge can be identified most clearly on the width versus discharge diagram, which indicates a large increase in width (from 165 feet to 540 feet) for a small change in discharge (1800 to 2,000 cfs) as the channel overtops its bank and uses the floodplain to carry part of the discharge.

The hydraulic geometry equations were used to calculate the peak velocity for the maximum discharge for each time interval, specifically, the discharge versus velocity graph. Doing this allowed showed that intervals with high discharges exhibit higher velocities and as a result greater rates of erosion for the time interval. Table 5 shows the erosion pin data and their association with velocity and discharge.

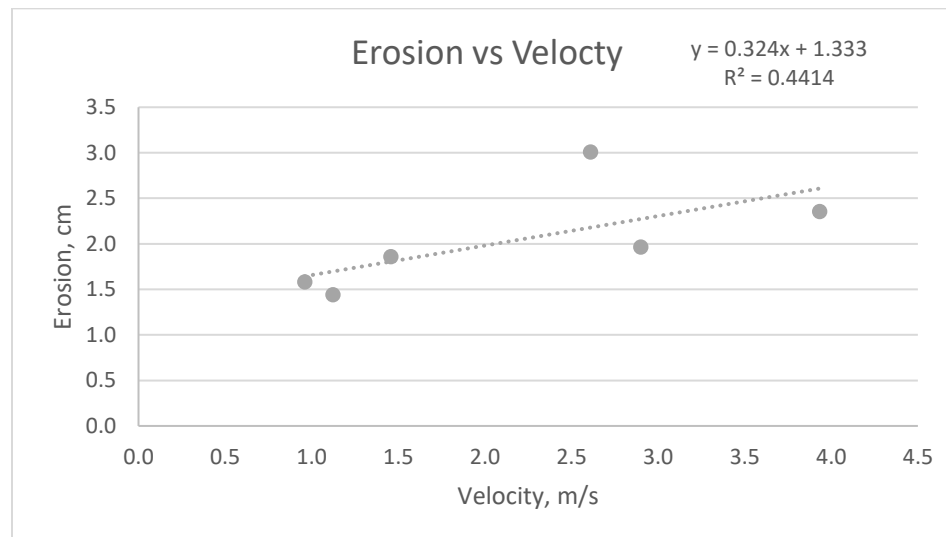
Figure 13. Showing the relationship between velocity and amount of erosion.

Below are the erosion pin data for the five time intervals over which I measured erosion and the associated discharge and velocity values. The erosion data for each time interval shows that the erosion is approximately 1 cm or more, the relationship between peak velocity and erosion is shown in figure 13.

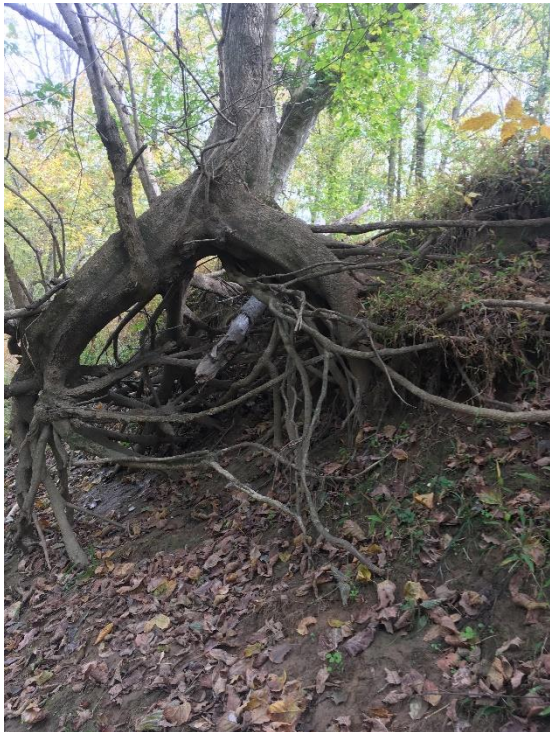
Figure 15. Showing the exposed roots of a tree and the eroded bank behind it.

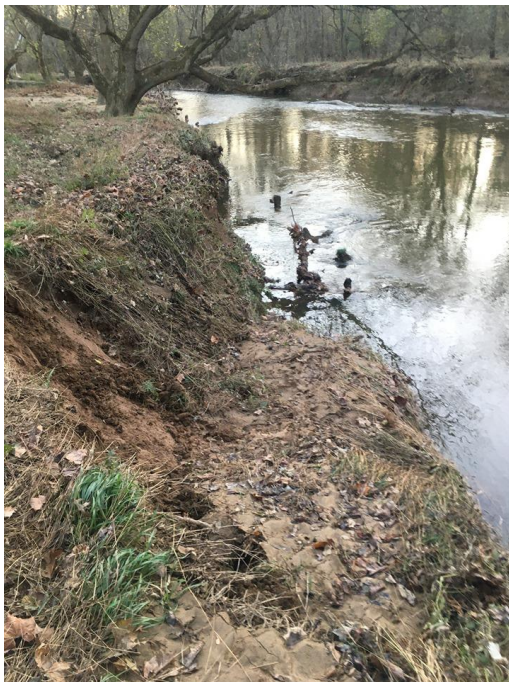
Figure 17. Showing a mass wasting event in which a section of bank slid into the river.

Using the Randle equation as a guide I evaluated the importance of the parameters associated with erosion rate. Many of the parameters were found not to be very useful within a reach, rather than among reaches. Some of these parameters were: Rooting depth, large woody debris, the height of debris jams, and bed sediment concentration. This is because the banks of the study reach had a consistent sediment make-up of clay/silt along the lower half to a coarse sand on top that were consistent throughout the reach. The debris did not have an effect on the erosion rates because there was either no large woody debris present or the velocities were high enough to wash them away. Rooting depth was found not to be strongly correlated with erosion rate as stated above since we see that migration rates vary significantly across varying rooting depths. What I did find was that velocity and radius of curvature are more important within this reach, both were observed to affect the erosion rates significantly as shown above. Velocity increases erosion rate and during the study there were multiple storm time intervals that exhibited different velocities with their individual erosion amounts varying as well (Table 3.), velocity has been increasing in this area through time due to urbanization. The radius of curvature to width ratio was also found to be an important factor that controls erosion rate. This is similar to the findings of Hicken and Nanson (1983), in which they found that radius of curvatures from 2 to 3 had the highest migration rates, which is also similar to what is shown in figure 14. Observationally there were many mass wasting events in which the bank slid into the

river as it was undercut by high velocity water, these events usually happened in bends and were seen mostly after larger storms (figure 17).
