# Evaluating Hydraulic and Vegetative Effects on River Bank Erosion

Dario Terzic, Advised by: Dr. Karen Prestegaard

GEOLOGY 393; University of Maryland

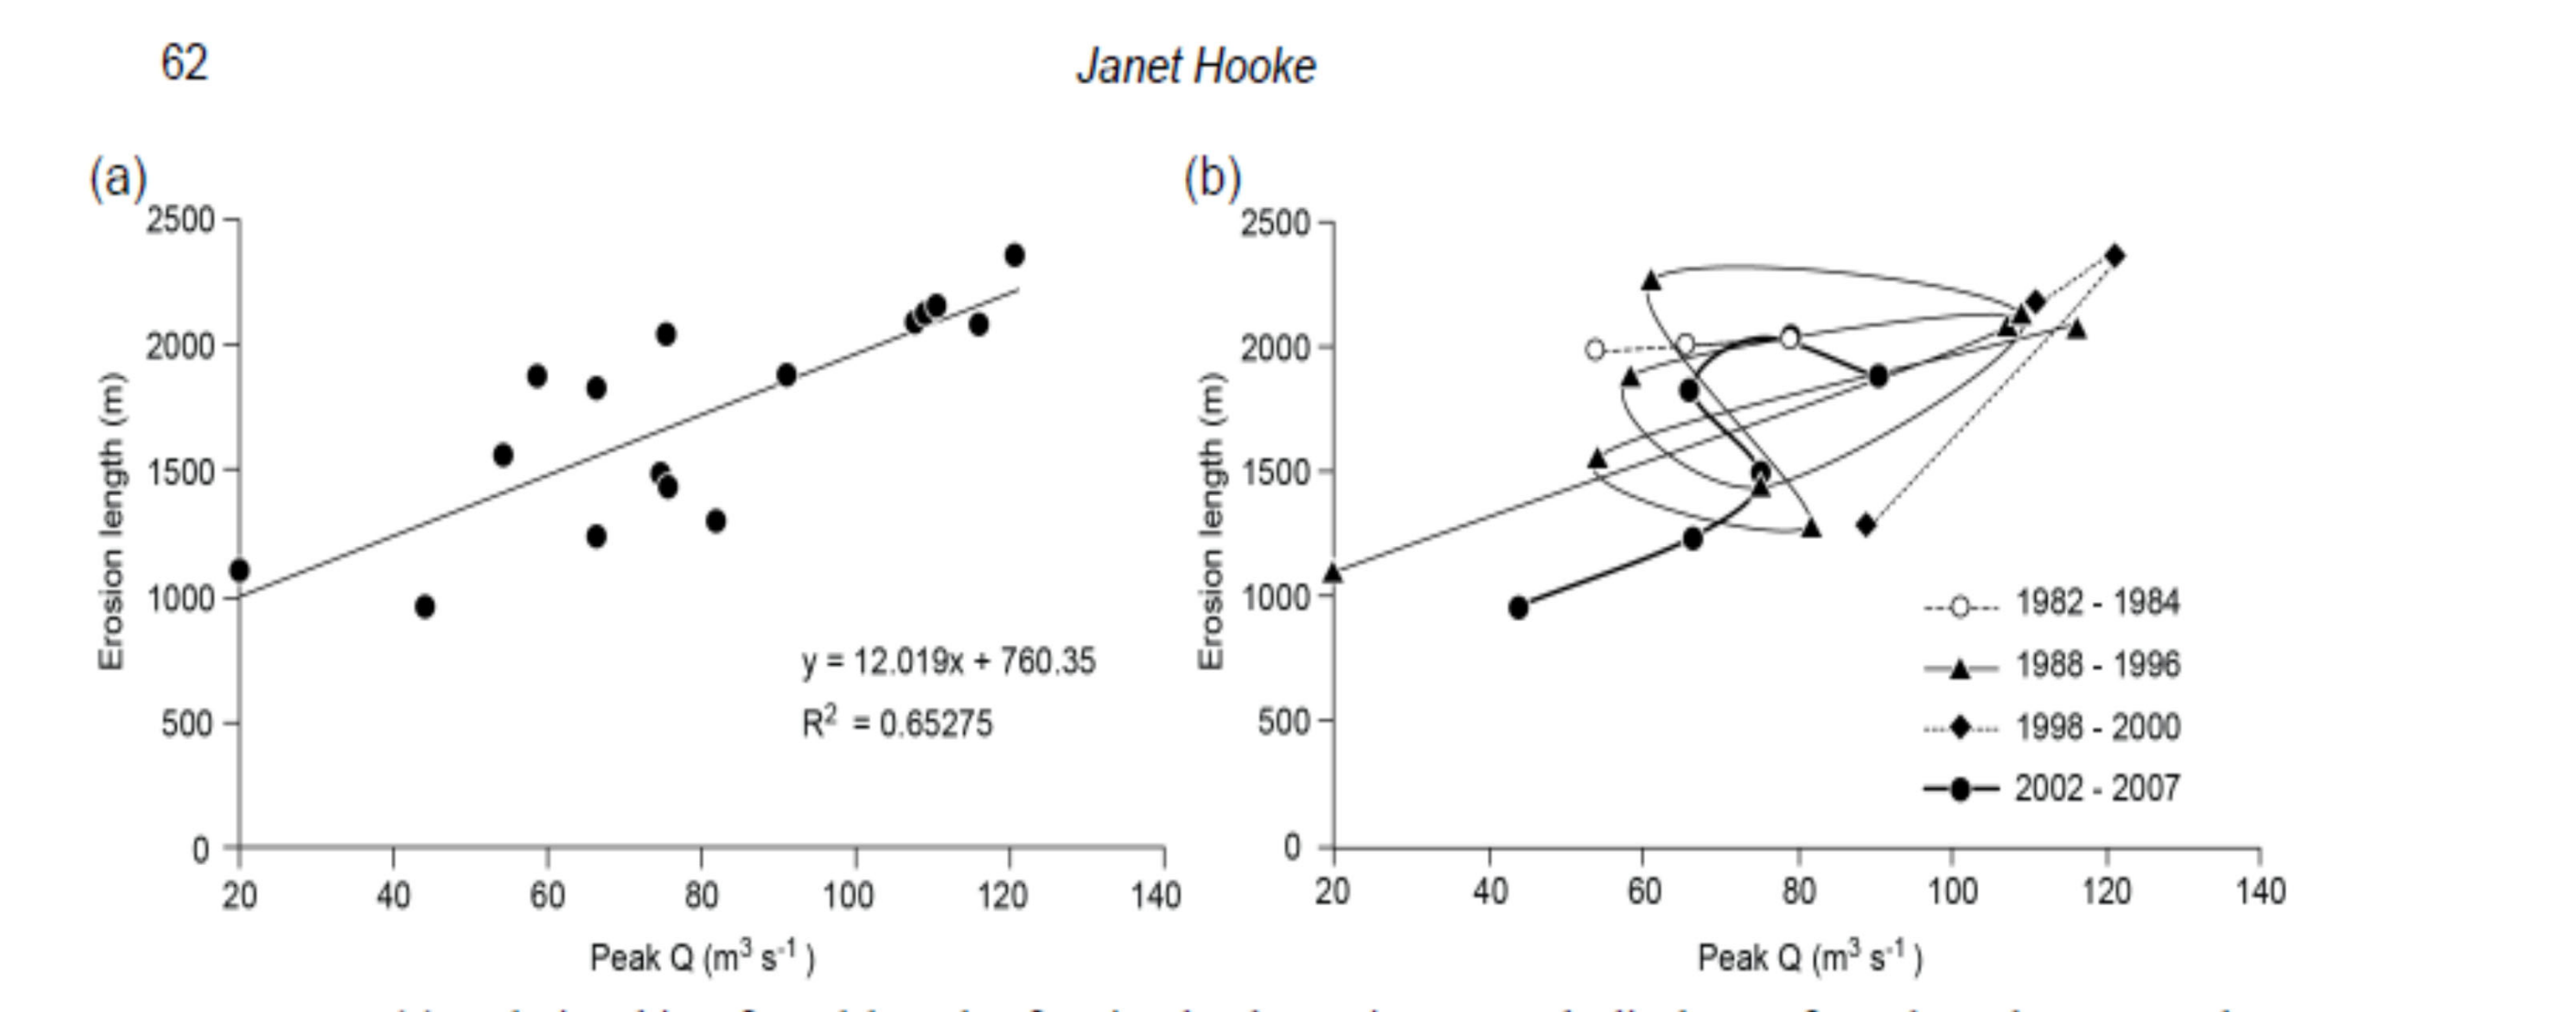
(Figure 1. Taken showing the relationship between erosion length and peak discharge. (Hooke 2012))

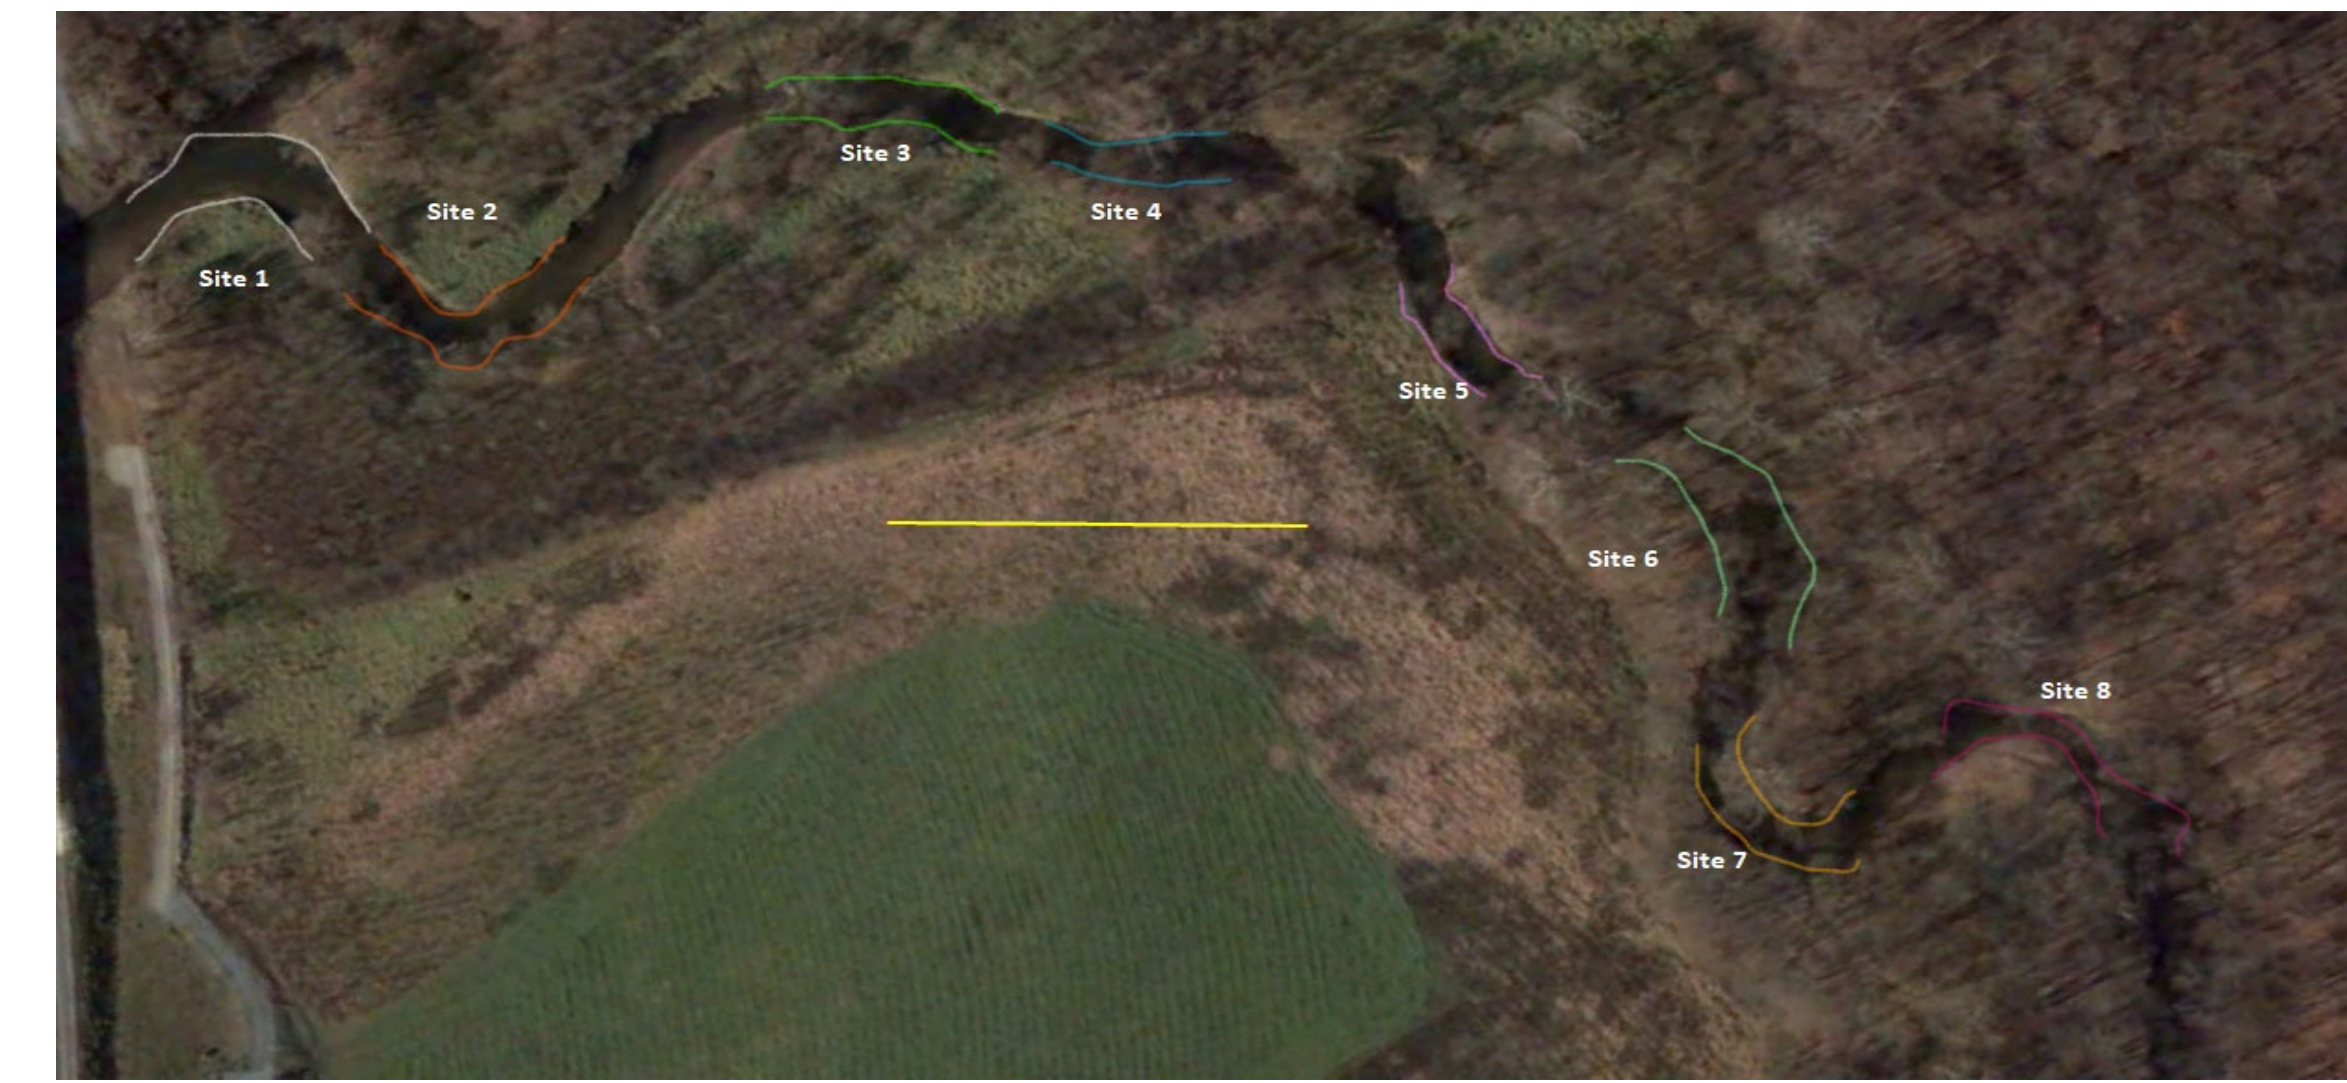
(Figure 2. An air-photo of the study area displaying where specific sites for measurements are located. The superimposed yellow bar is 100 meters and the grey arrow is north direction.)

The study reach is a section of Seneca Creek near Dawsonville Maryland. The site was selected because of high rates of bank erosion, location near a USGS gauging station, and an increase in annual maximum discharge.

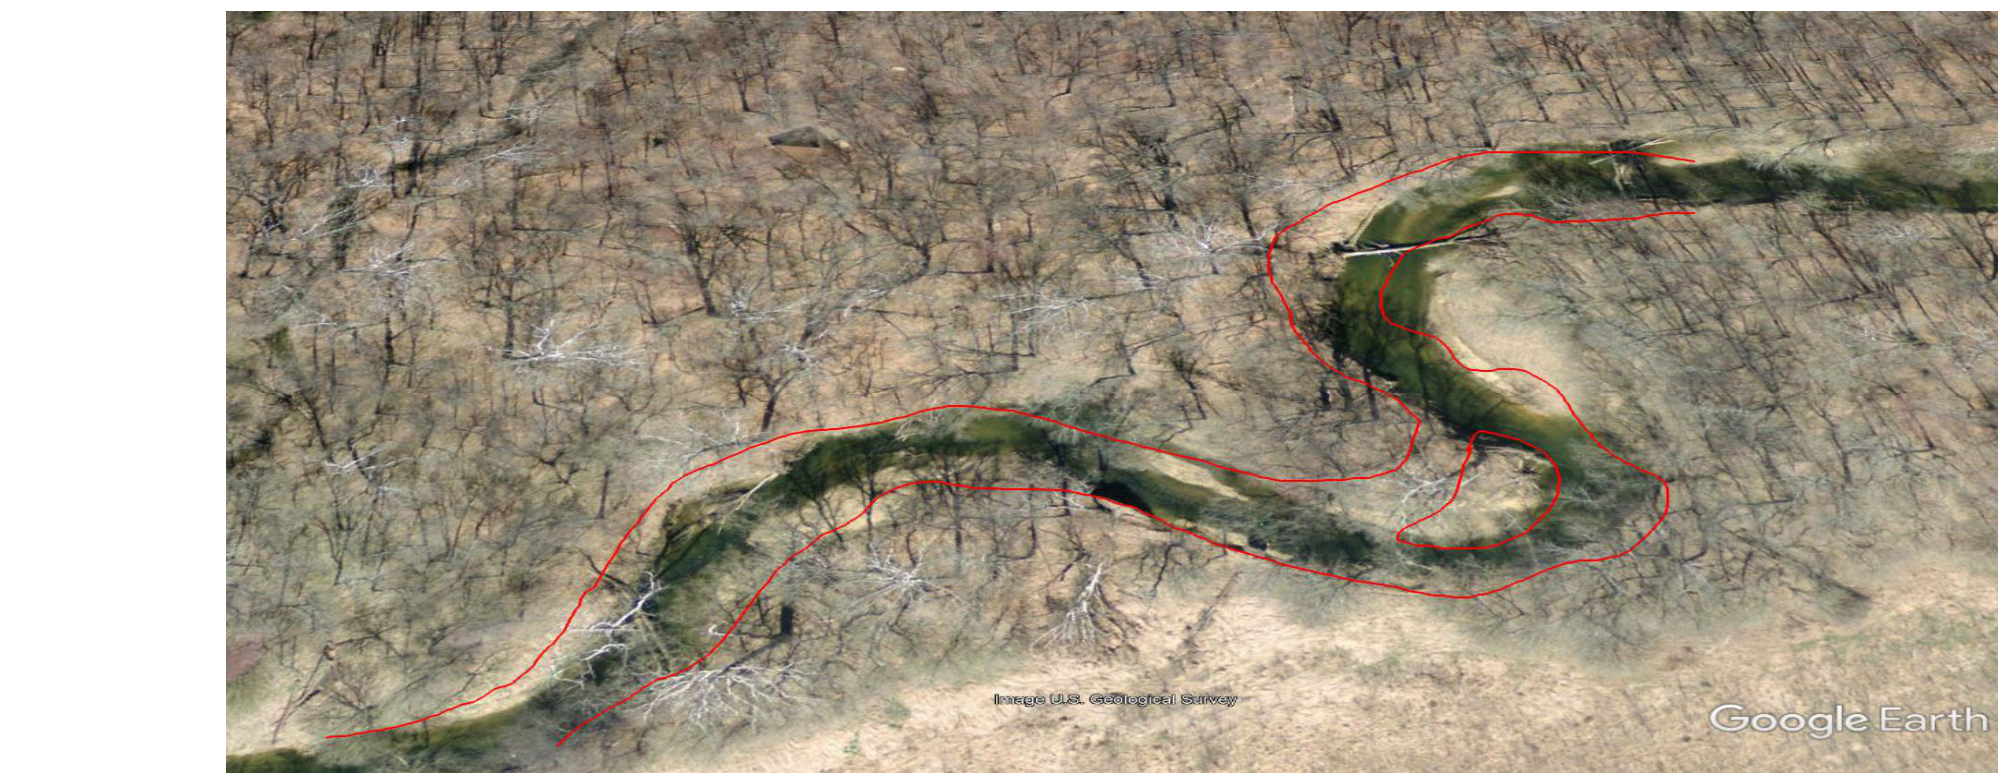
Figure 4. Migration rates determined from area change from air photos 2008 - 2018
