Longitudinal Changes in Stream Chemistry and Discharge Influenced by Streamflow in a Restored Stream

Joseph Malin (GEOL 393)

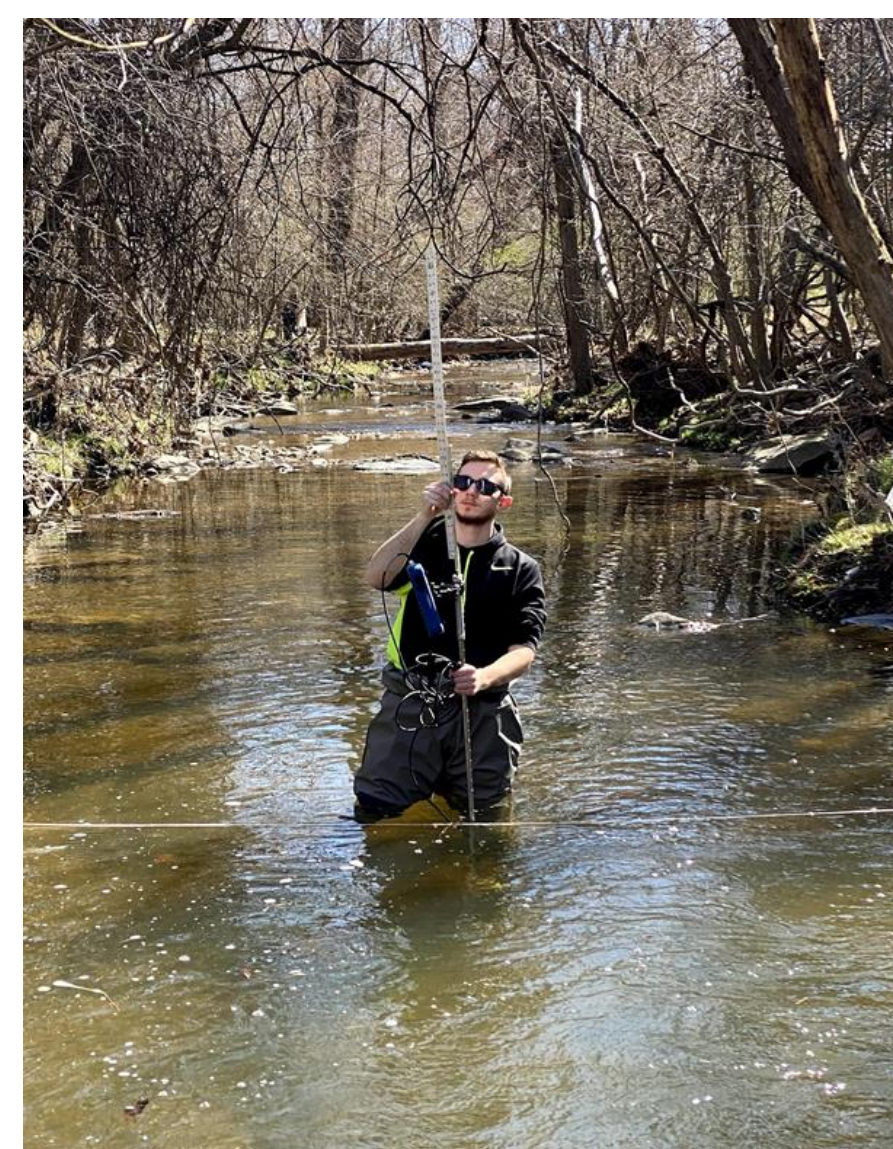
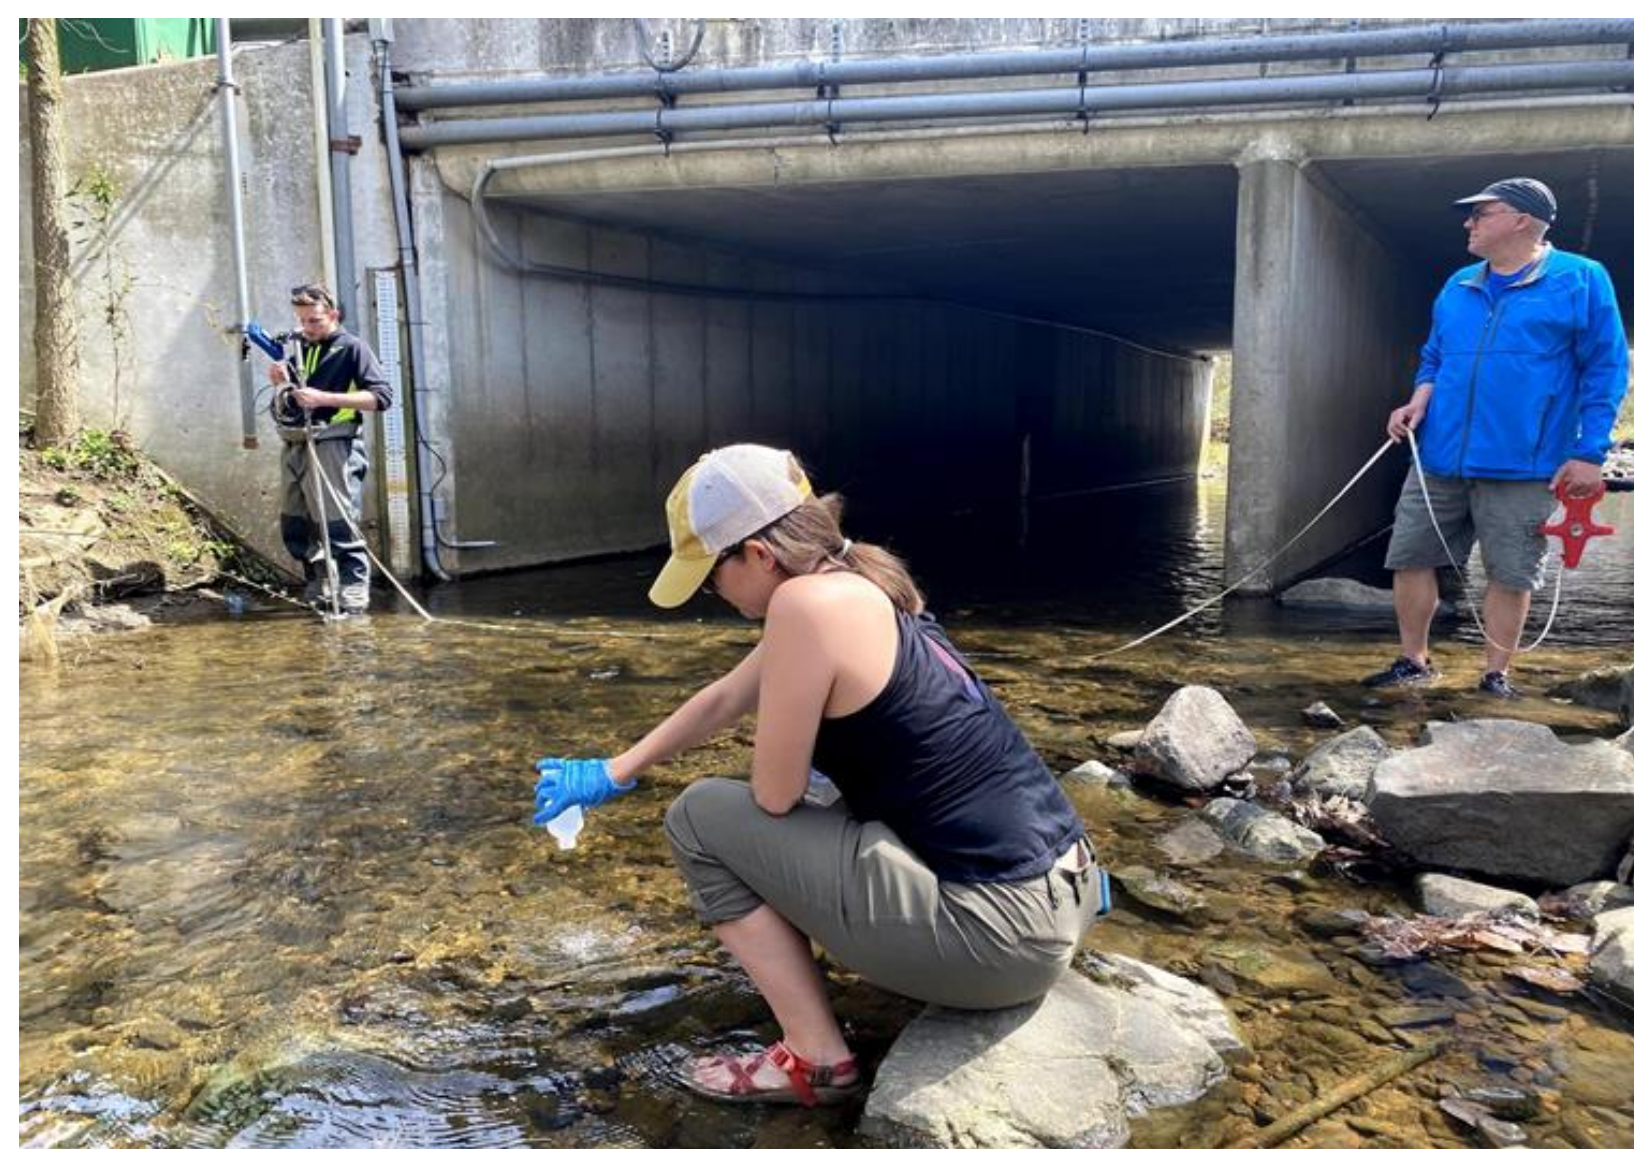
Figure 2: Data collection procedures shown at Site 7 (Greenway Bridge) (Left) and Site 10 (Rolling Rd) (Right).

Site 10 features the USGS Stream Gage and associated measurement tools.

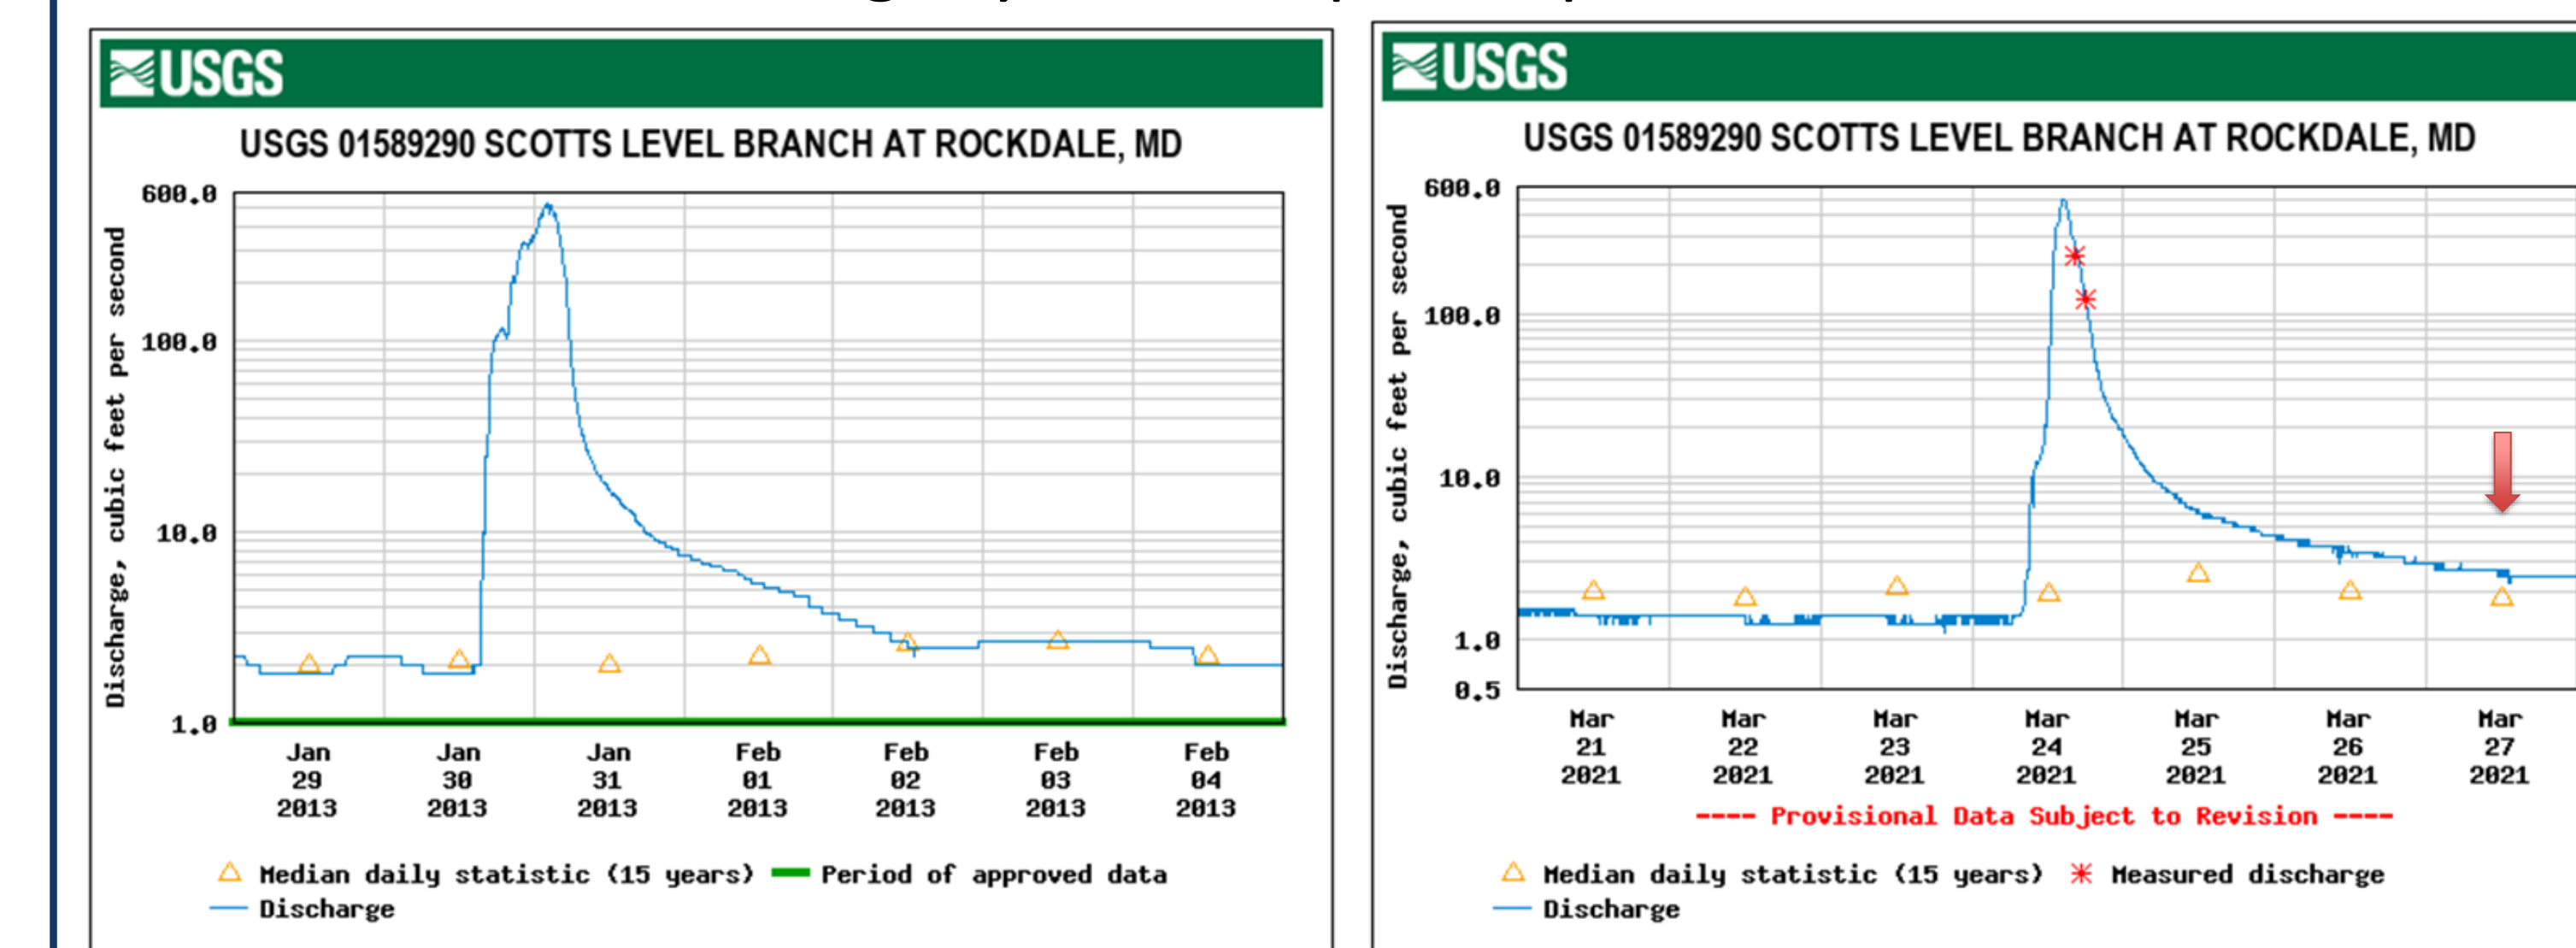
Figure 6: Select USGS Stream Gage Data (Site 10)

SLB discharge data from Jan 2013, before restoration project (Left) compared to data from Mar 2021, during restoration project (Right).

- Discharge returning to base level after comparable precipitation events.
- Similar rises and falls from pre- and post-restoration.
- Post-restoration is slightly less steep than pre-restoration.

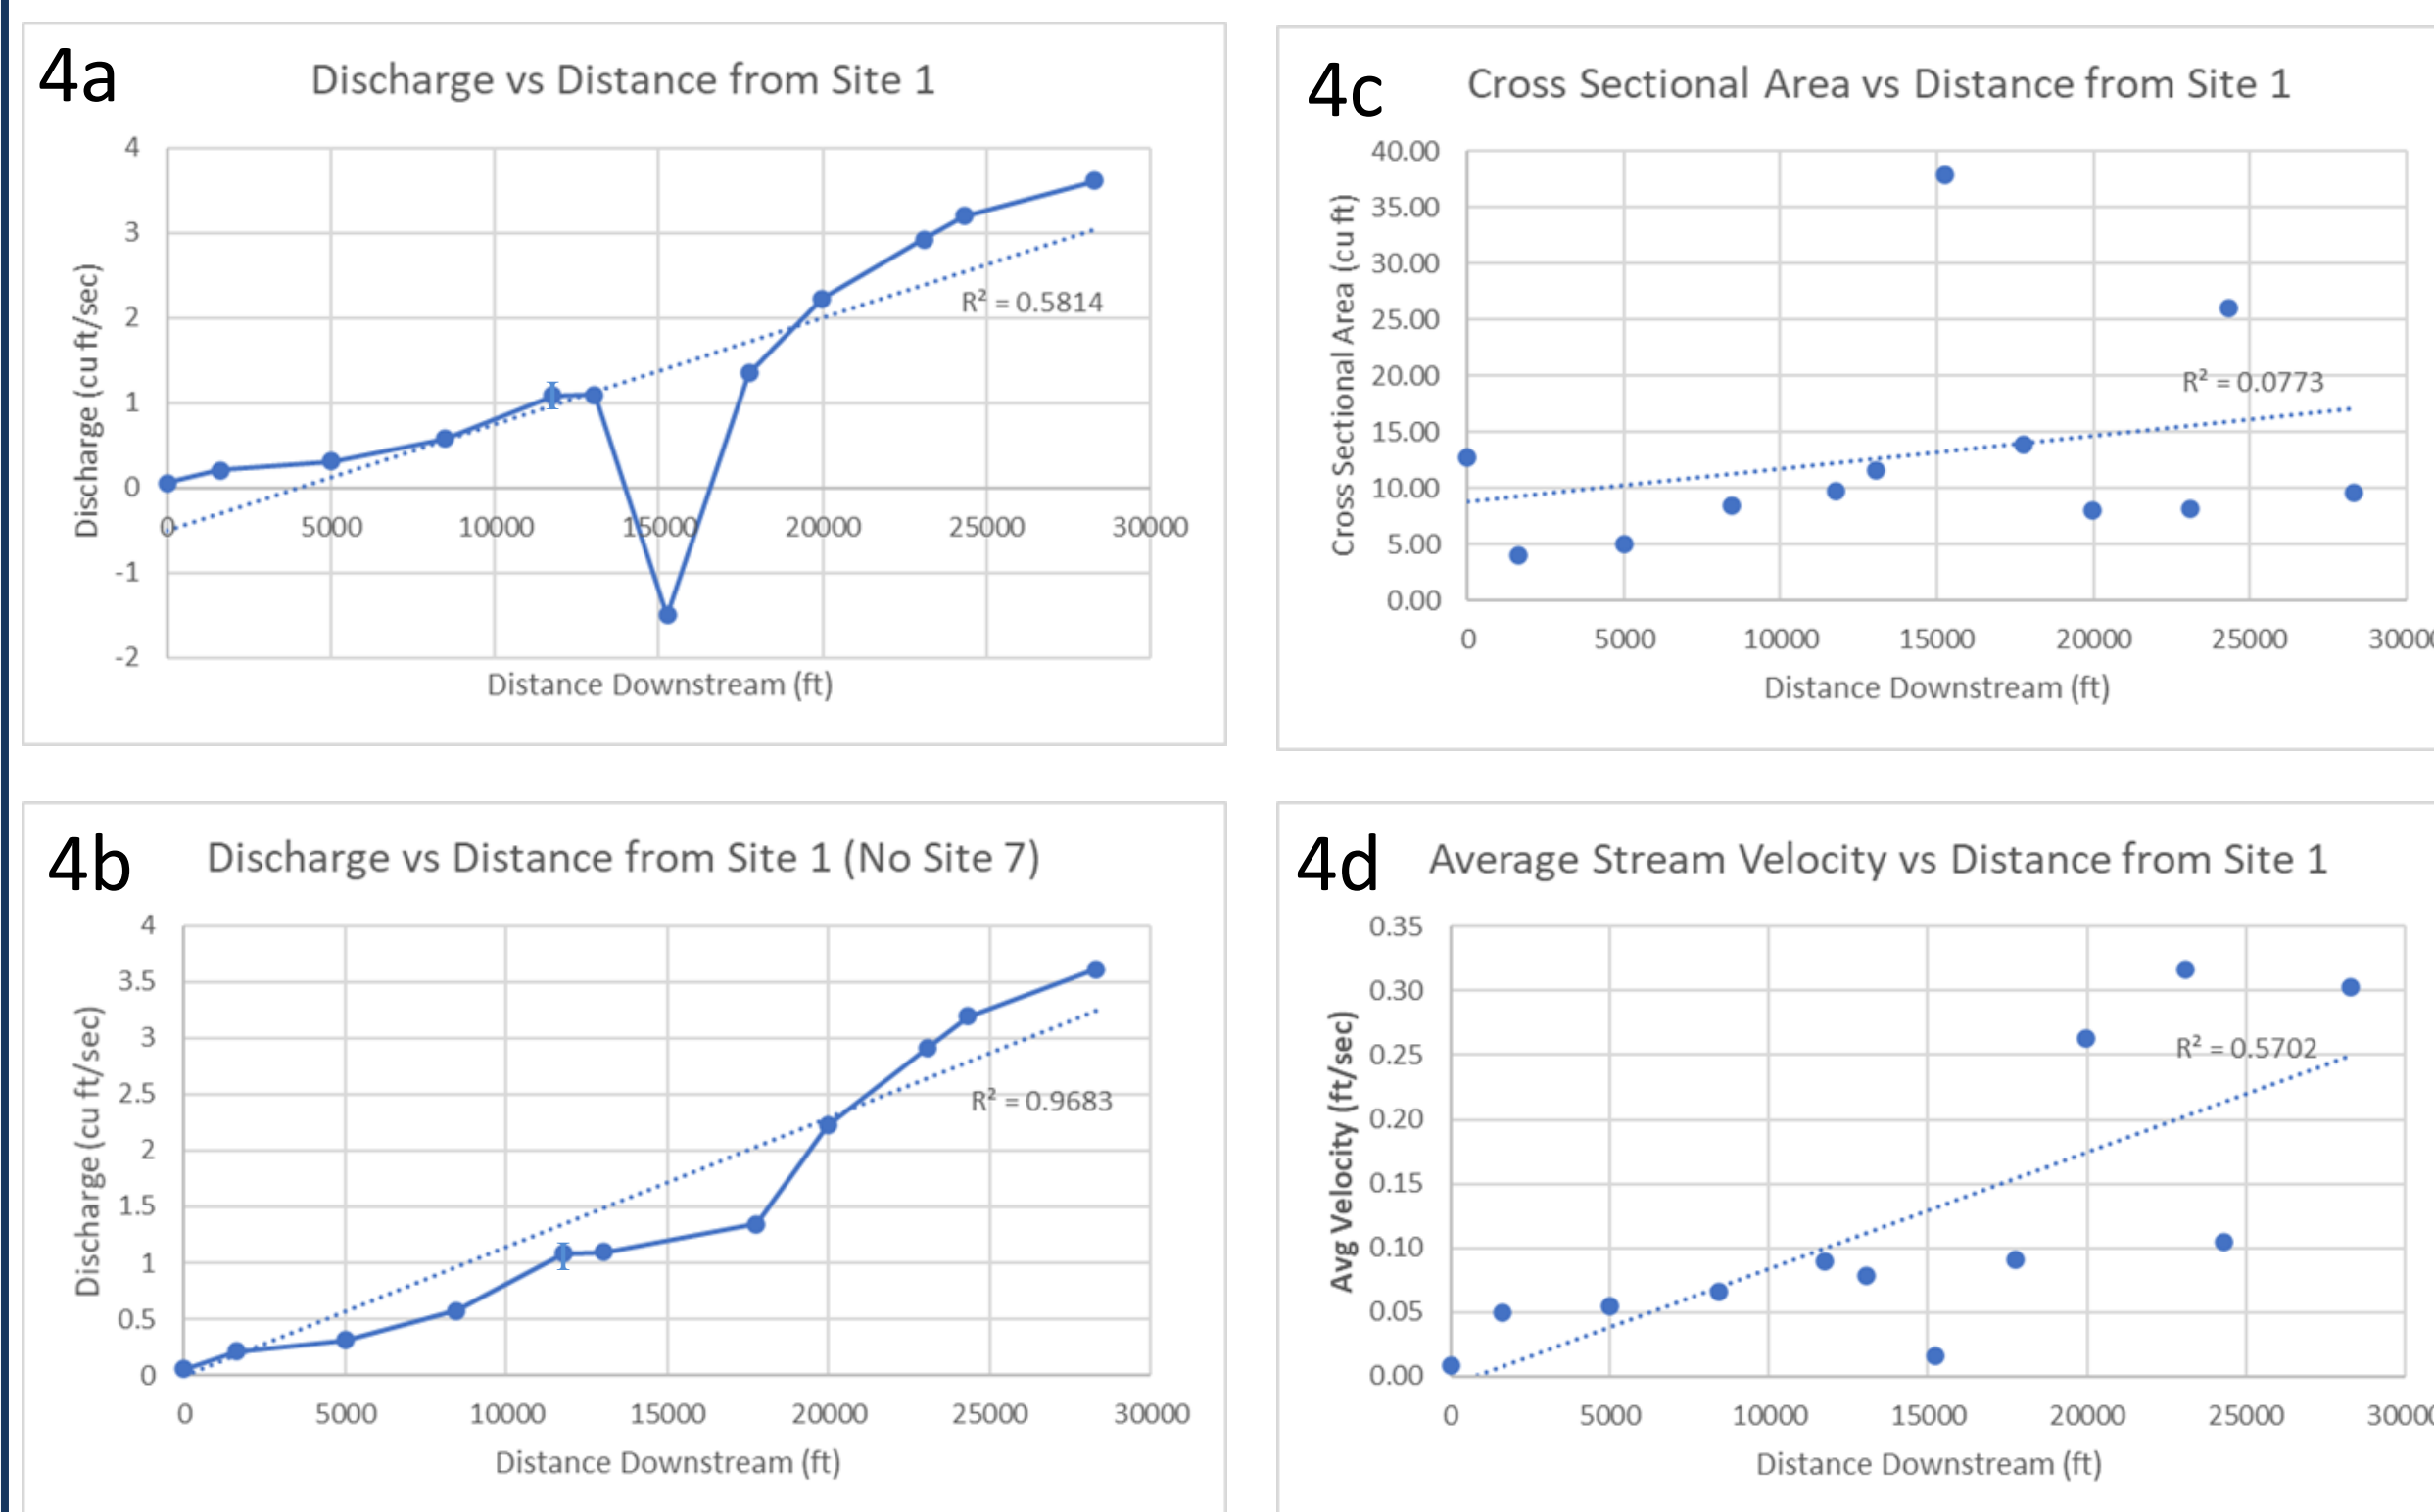
Figure 4: Stream Flow and Geometry

- Discharge increases from site to site when Site 7 outlier is not considered (4a & 4b).
- Average stream depth and width plots presented increasing downstream trends, indicating an increasing cross-sectional area trend (4c).
- Depth to width ratio showed slight increasing trend downstream.
- Average stream velocity showed an increasing trend downstream (4d).

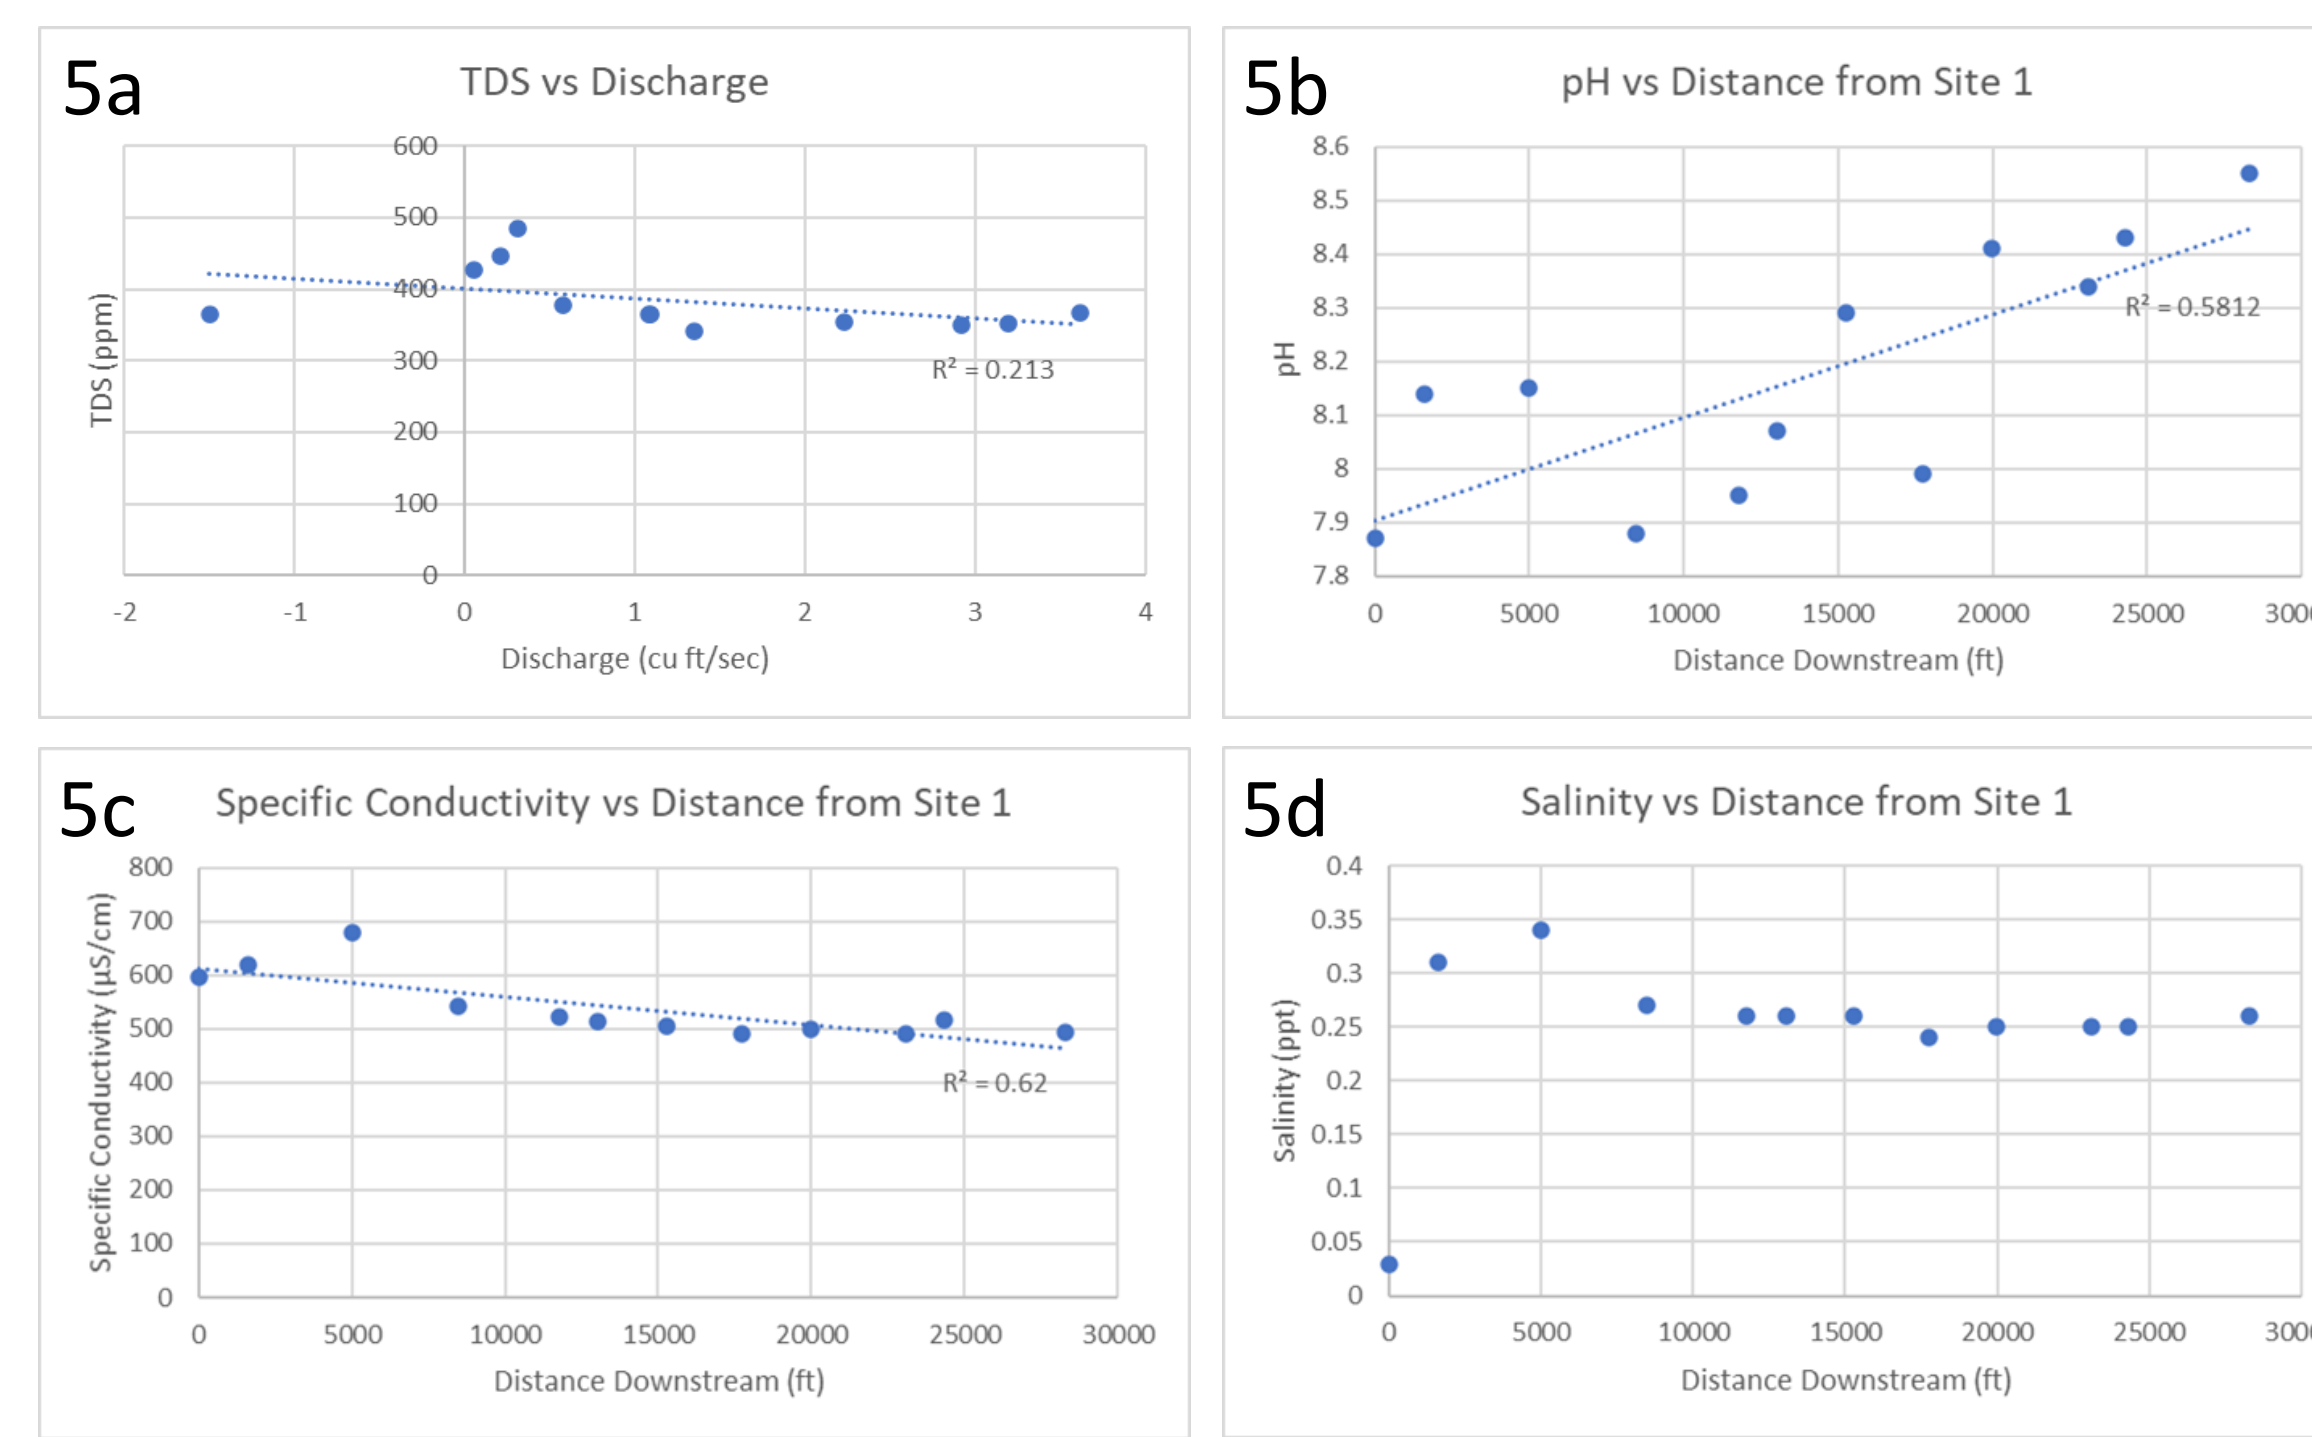
Figure 5: Water Chemistry

- Dilution in total dissolved solids relative to discharge (5a).
- pH increases with water temperature due to photosynthesis of nearby plant life pulling CO₂ from the water (5b).
- Correlation between specific conductance and salinity expressed by similar decreasing trends downstream (5c & 5d).

- Changes in streamflow will impact stream geometry downstream as discharge and stream velocity affect rate of erosion of streambed.
- Dilution of total dissolved solids, as well as decreasing salinity downstream, agrees with hypothesized change in stream chemistry.
- Analysis of pre- and post- restoration are required for best analysis of hypothesis, so future data collection after the project is needed.
